An Investigation into the influence of ageing components on medium voltage network configurations in Semi-Urban areas

Dissertation submitted in fulfillment of the requirements for the degree:

Master of Engineering

Central University of Technology, Free State

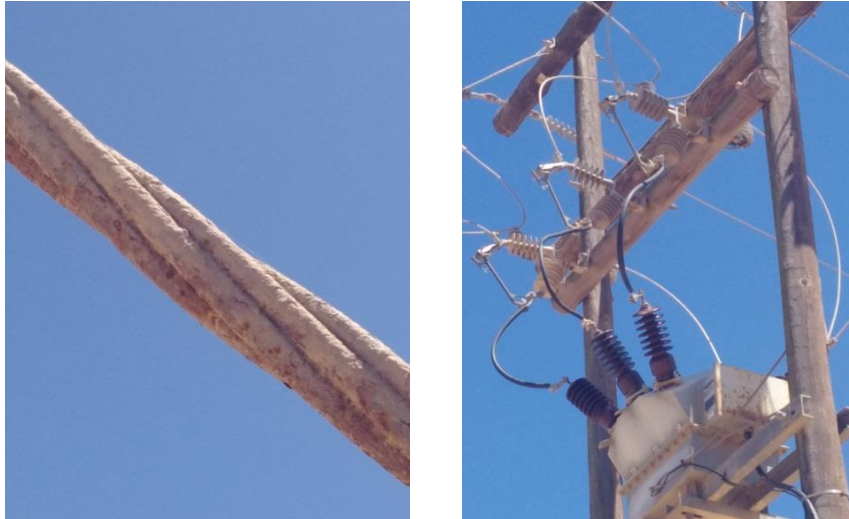
Sizamile is located approximately 1.39km from the Atlantic Ocean just outside Port Nolloth. Due to its close proximity to the ocean, the area experiences high moisture generated from the sea as the water evaporates. Moisture can have an effect on the rate at which the metallic material deteriorates [66]. Any metal components such as conductors, pole-mounted transformer tanks, jumpers and stays that are exposed to high salty moisture from the ocean have a high chance of corroding as shown in Figure 4.5 and 4.6.

Figure 4.5: a) Corrosion on the conductors, b) Ageing and corroded breaker

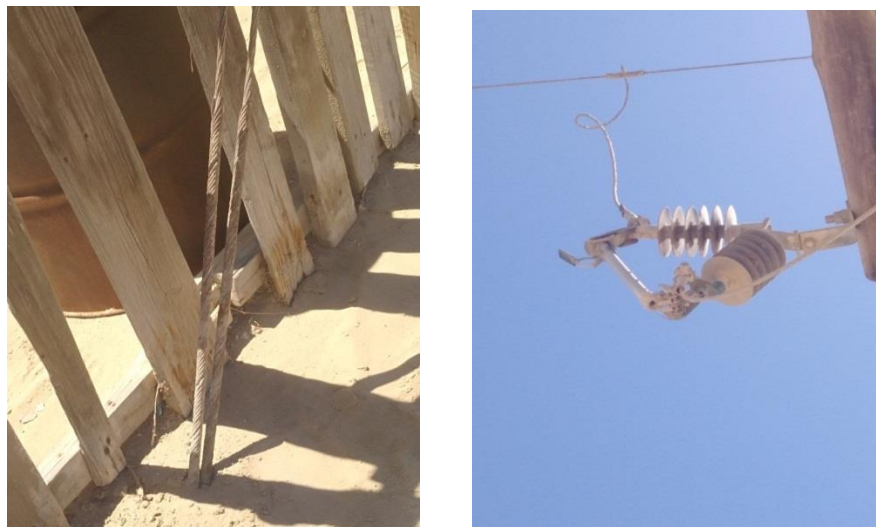
Although the electrical network in Sizamile is only 27 years old, the rate at which it has corroded is shown in Figures 4.6a and 4.6b.

Figure 4.6: a) Corrosion on the stay on one of the poles, b) Corrosion on one of the newly installed jumpers

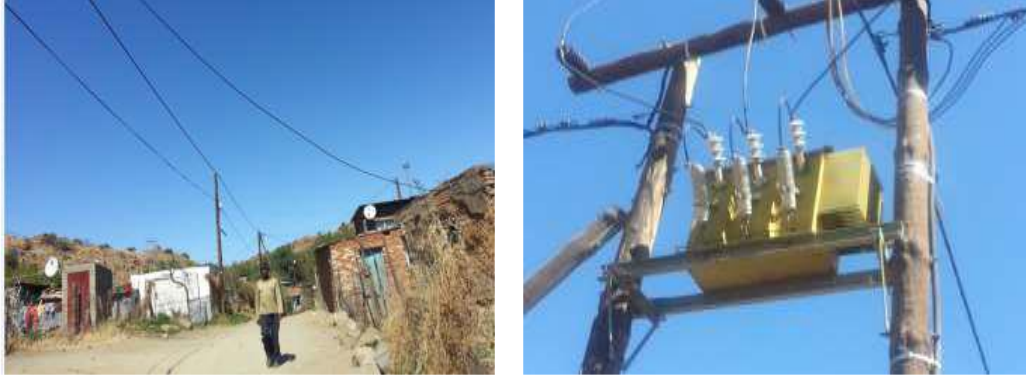
Figure 4.8: a) Low hanging concentric cables in Kuyasa, b) Pole-mounted transformer installed without MV Fuses on the primary side

Lines that are very close and above customers' properties are shown in Figure 4.8a. A pole-mounted transformer without fuses is depicted in Figure 4.8b. Having MV fuse-links ensures that whenever there is a fault on a pole-mounted transformer, the affected transformer can be isolated from the rest of the network.

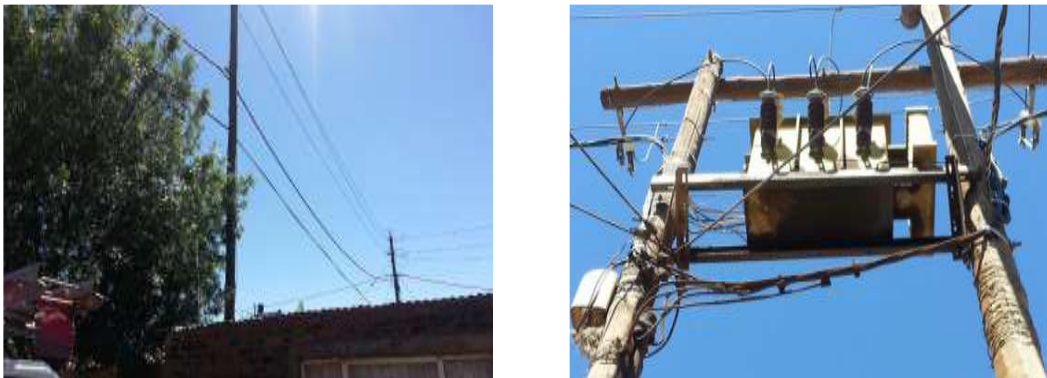
Figure 4.9: a) MV and LV lines connected to the same poles, b) An overloaded transformer

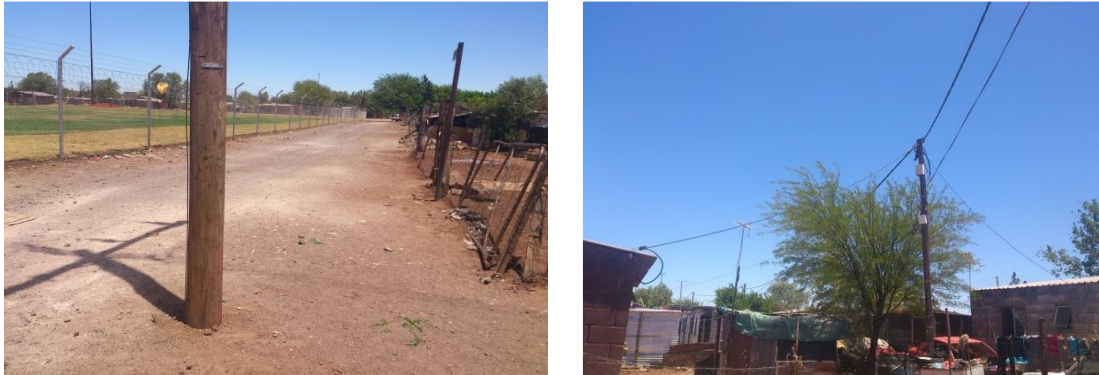
In Figure 4.11a and 4.11b, the condition of the electrical network in Newtown showing wood pole structures, the LV network and pole-mounted transformers is highlighted.

Figure 4.11: a) A pole in the middle of a street, b) Tree underneath the line

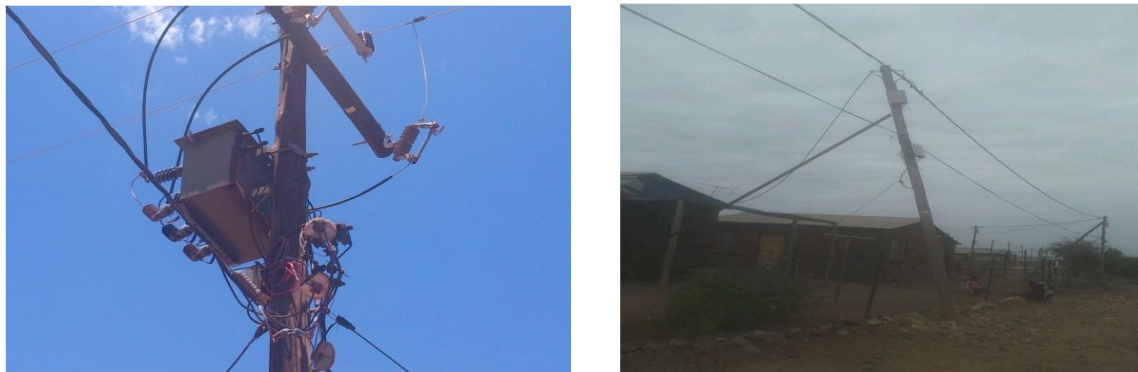
Figure 4.12: a) A pole-mounted transformer with oil leaks, b) One of the leaning LV poles in Newtown

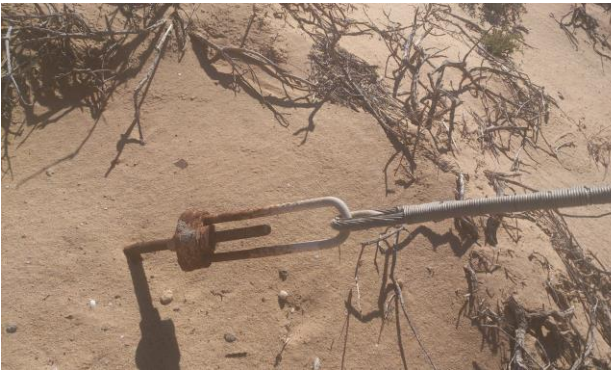
Fig .7. Stay which is affected by Rust in Sizamile.

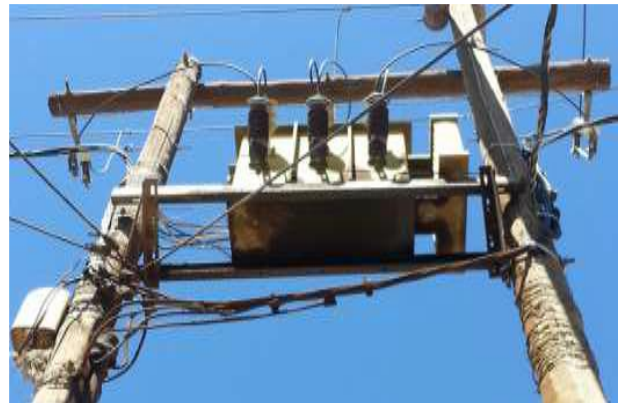
Fig .10. Leaking Pole Mount Transformer due to Overloading
