THE DETERMINATION OF MOISTURE VARIATION PATTERNS IN CLAY SOILS UNDER A LIGHT STRUCTURE HOUSE

A thesis submitted in fulfilment of the requirements for the degree
Master of Engineering in Civil Engineering
in the
Department of Civil Engineering
of the
Faculty of Engineering and Information Technology
of the
Central University of Technology, Free State, South Africa

December 2017

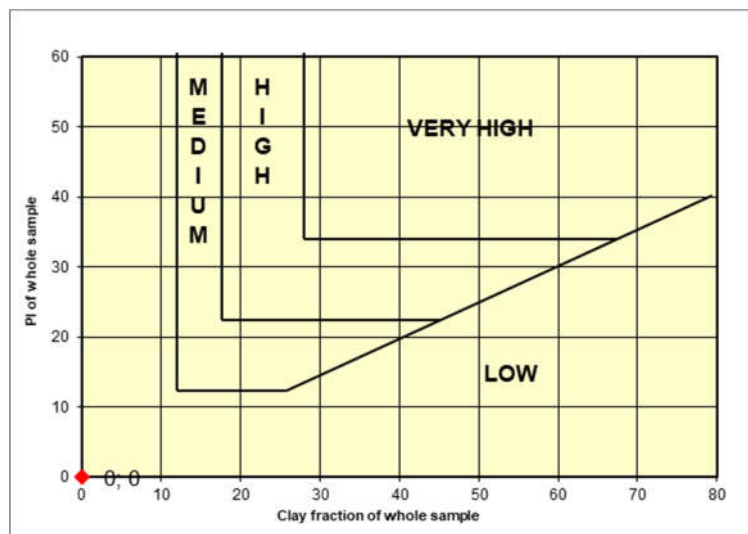
On the Van der Merwe's swell prediction chart Figure 2-10 the PI of the whole sample is plotted against the clay content to determine the heave potential of the clay. This heave potential can be either low, medium, high or very highly expansive. The in situ moisture content should also be considered, because the heave potential of the soil is the potential total heave for a moisture change from a dry to a saturated condition.

Figure 2- 9: Van der Merwe's chart for heave prediction (Van der Merwe 1964)

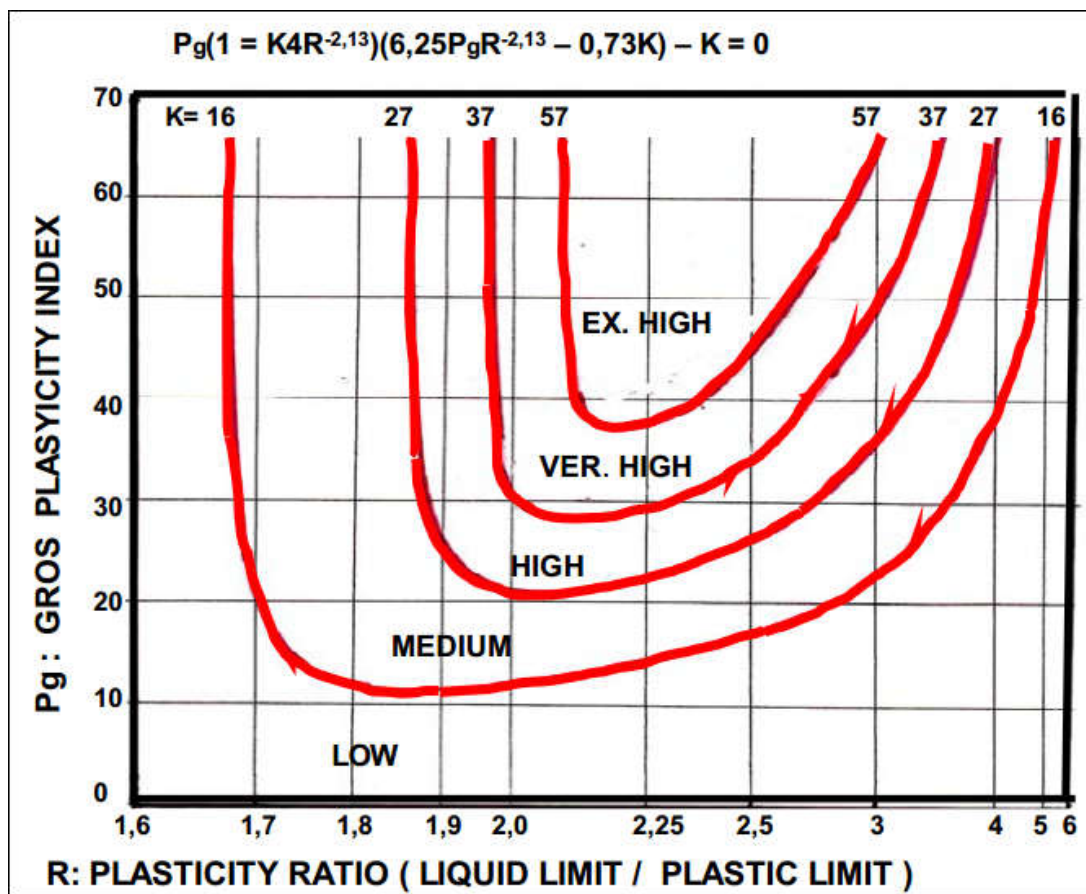
The Savage method, using the van der Merwe’s zones of swell potential, is mathematically calculated or read from a chart giving the swell potential of a soil from the value of R and material passing the 0.425mm sieve. The use of the R value (LL/PL) for a soil and the PI gross will allow assessment of active soils quickly by using the chart below in Figure 2-10 (Savage, 2007). Savage has established a mathematical derivation of lines representing swell potential by a factor K, certain values of which define the swell zones approximating those of van der Merwe (1964)

Figure 2-10: Swelling potential of soil by use of the Atterberg Limits of Plasticity Index and Plasticity Ratio (Savage, 2007)

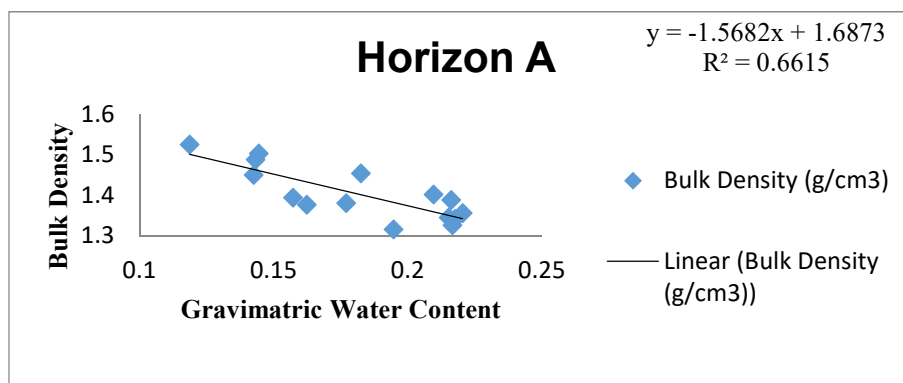
The Bulk densities were determined and plotted against gravimetric moisture content for each horizon in the test pit, after which a linear regression was done to determine a formula which was used in the determination of the bulk density at a specific moisture content.

Figure 3-8: Horizon A

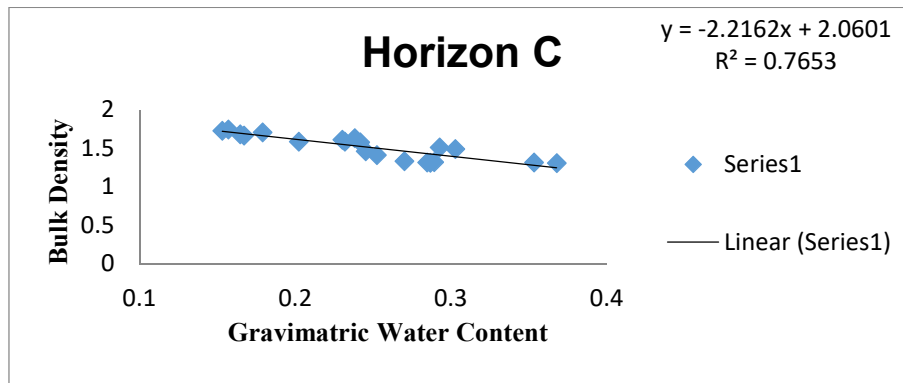
Figure 3-10: Horizon C

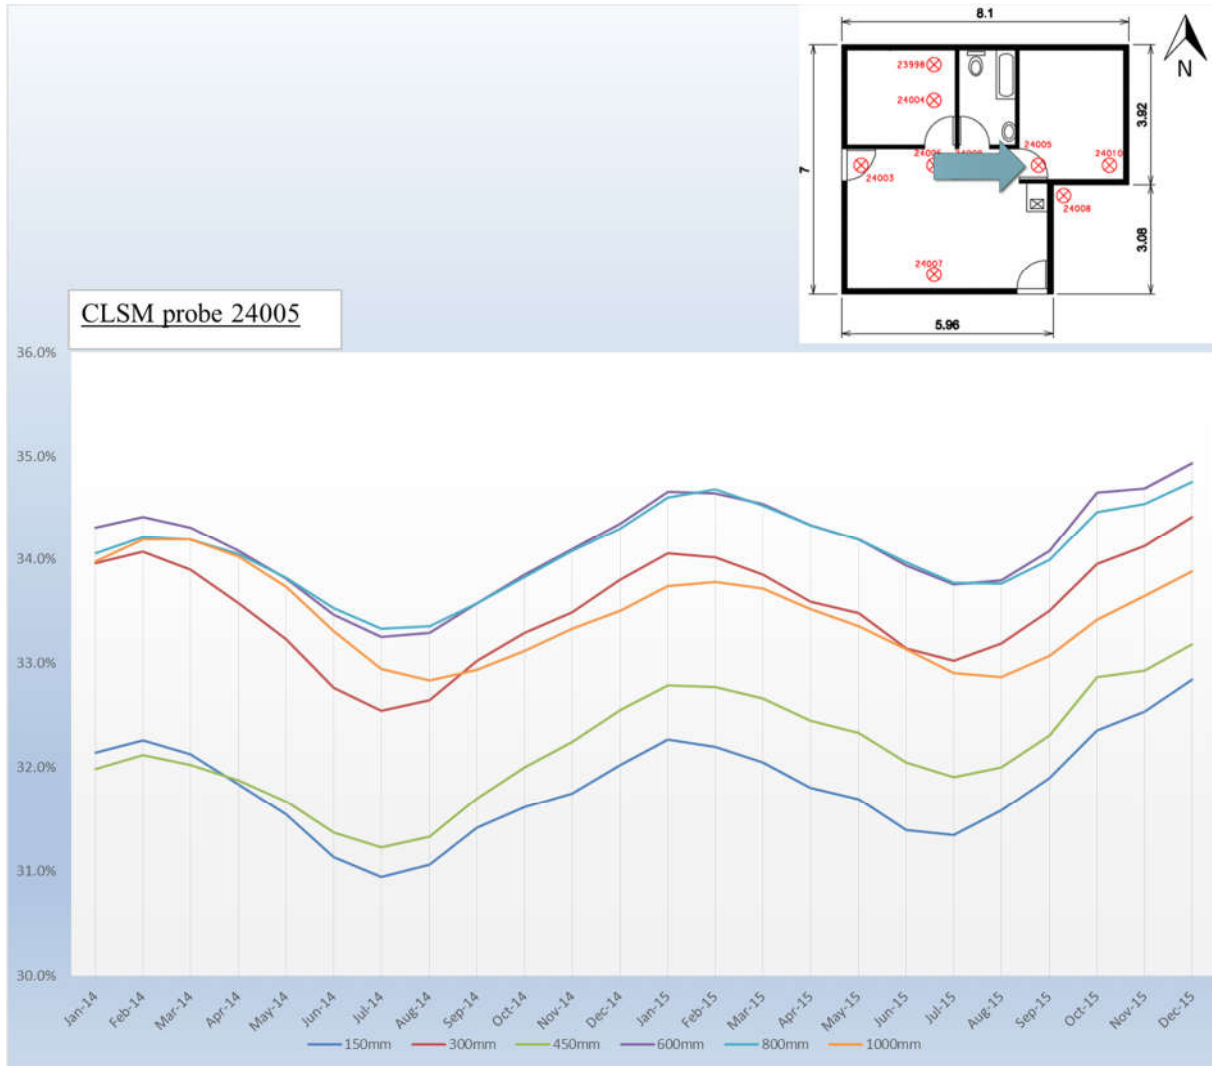
Figure 4-7: CLSM probe 24005 monthly average moisture variation for 2014 and 2015

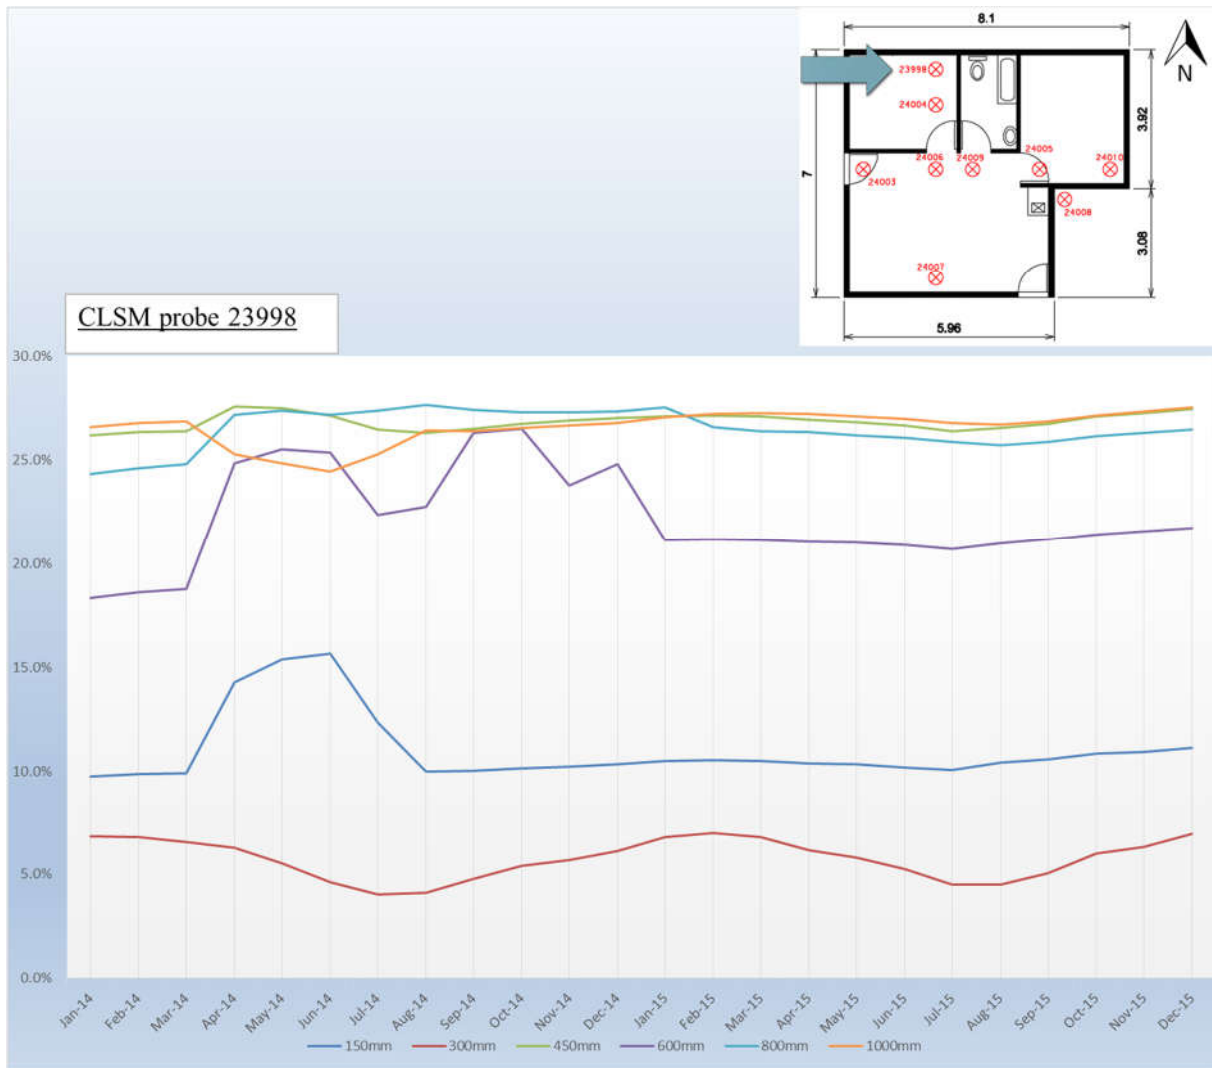
Figure 4-13: CLSM probe 23998 monthly average moisture variation for 2014 and 2015

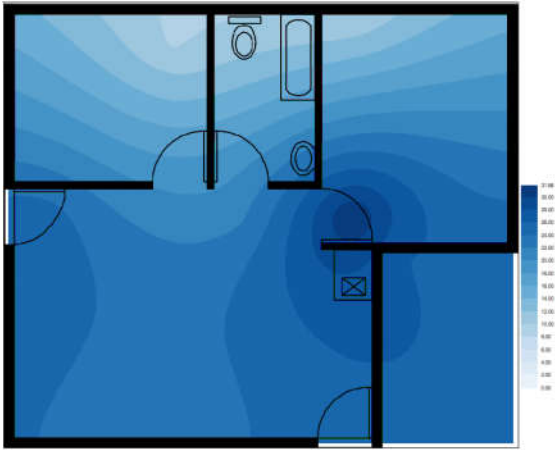
APPENDIX D - Figure: 1: 2014 January
150mm MC: 9%-32%
