**An assessment of the impact wastewater
pollution has on the quality of surface water
bodies in the vicinity of Zastron and
Matlakeng Township, Free State Province**

**MASTER OF HEALTH SCIENCES IN
ENVIRONMENTAL HEALTH**

Central University of Technology, Free State

2019

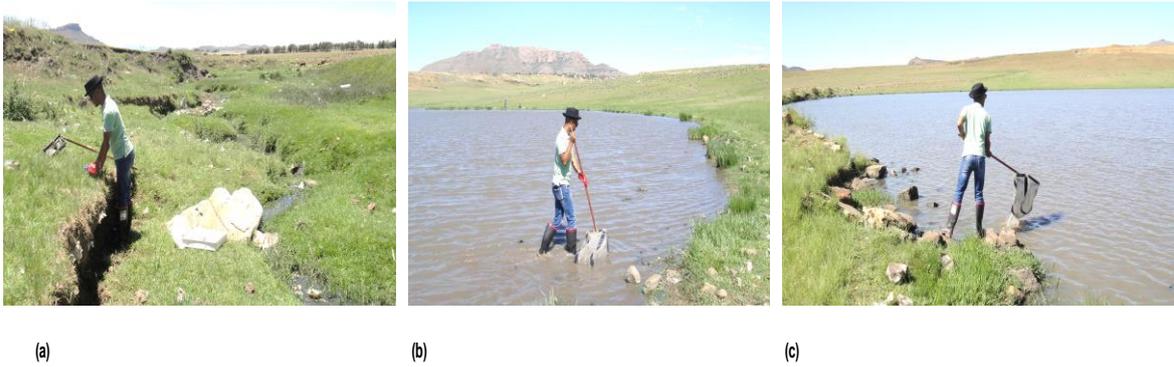
Figure 3.7 Collecting macroinvertebrates from different biotopes (a) Vegetation biotope, (b) stones in current biotope, (c) gravel, sand and mud biotope

1. For the collection of macroinvertebrates from the gravel, sand and mud the gravel, sand and mud was disturbed for one minute using wader boots.
2. Disturbing the gravel, sand and mud the SASS net was swept over the dislodged area to collect the macroinvertebrates.
3. All macroinvertebrates that were collected from the gravel, sand and mud biotope were then massed together to form the gravel, sand and mud biotope for macroinvertebrate collection.

Photos during the collection of macroinvertebrates at different sampling sites was taken at each of the three sampling rounds. In Figure 3.7, the collection of macroinvertebrates from the stones biotope, vegetation biotope and gravel, sand and mud biotope is depicted.

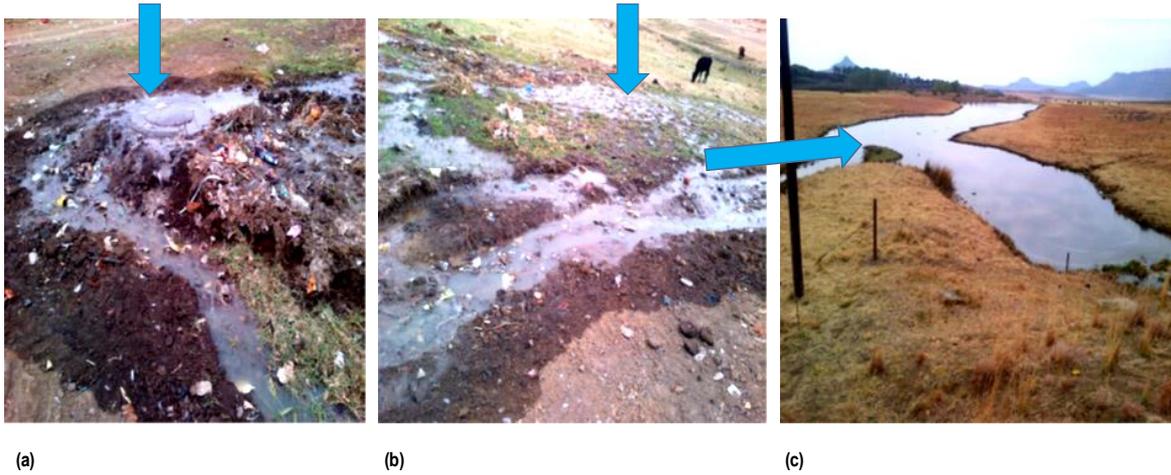
Figure 4.1 Pollution of surface water bodies (a) stream and dam pollution as a result of one blocked manhole spillage, (b) sewerage from the blocked manhole flowing into the adjacent environment and animals drinking the water containing raw sewerage, and (c) raw sewerage from the blocked manhole flowing into a localised river near Matlakeng Township

Figure 4.1 shows how blocked manholes resulted in extensive pollution of streams nearby the Matlakeng Township.
