**ASSESSMENT OF FACTORS AND MAINTENANCE
STRATEGIES RELATED TO RECURRING POTHOLES
IN BLOEMFONTEIN ROADS**

Dissertation submitted in fulfilment of the requirements for the Degree

MASTER'S IN ENGINEERING: CIVIL

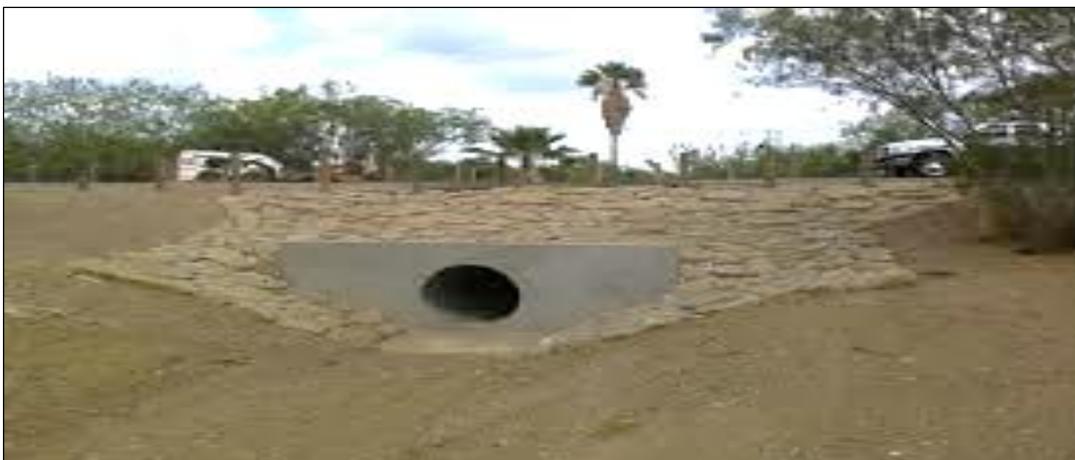
Figure 2.5: Culvert to drain storm water from a road network

Water in the road's asphalt layers can strip or separate the asphalt layer from the aggregate (Saad, 2014). Clearly, it is important to consider the drainage of a roadway. There are two basic categories of drainage – surface and sub-surface (COLTO, 1998). Surface drainage includes the disposal of all water present on the road-surface, shoulder-surface, and the adjacent ground when sloped toward the road using different forms of culverts or similar drainage structures (see figure 2.5). Sub-surface drainage system removes water from the surrounding soil of the road structure. Lack of attention to either of these two drainage systems can lead to structural failure of road. (COTO, 2012)

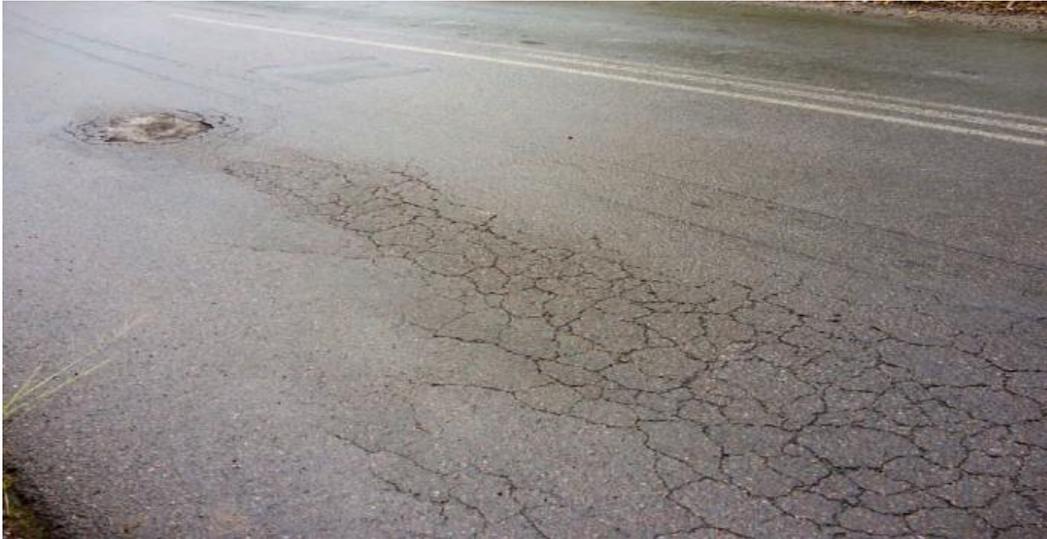
Figure 2.8: Cracking because of support failure

Cracks in an asphalt surface usually result from a poor support base or sub-base (Figure 2.8), which eventually leads to surface fatigue and cracking (Komba, 2010). The surface can also crack when subjected to extreme natural effects like sun, oxidation, heat or cold, which might cause the asphalt surface to expand and shrink. Also, when the underlying cement layers set, this might cause simultaneous cracking on the surface. The weakness in the underlying support layers results in high surface displacement under traffic loads (COTO, 2012)

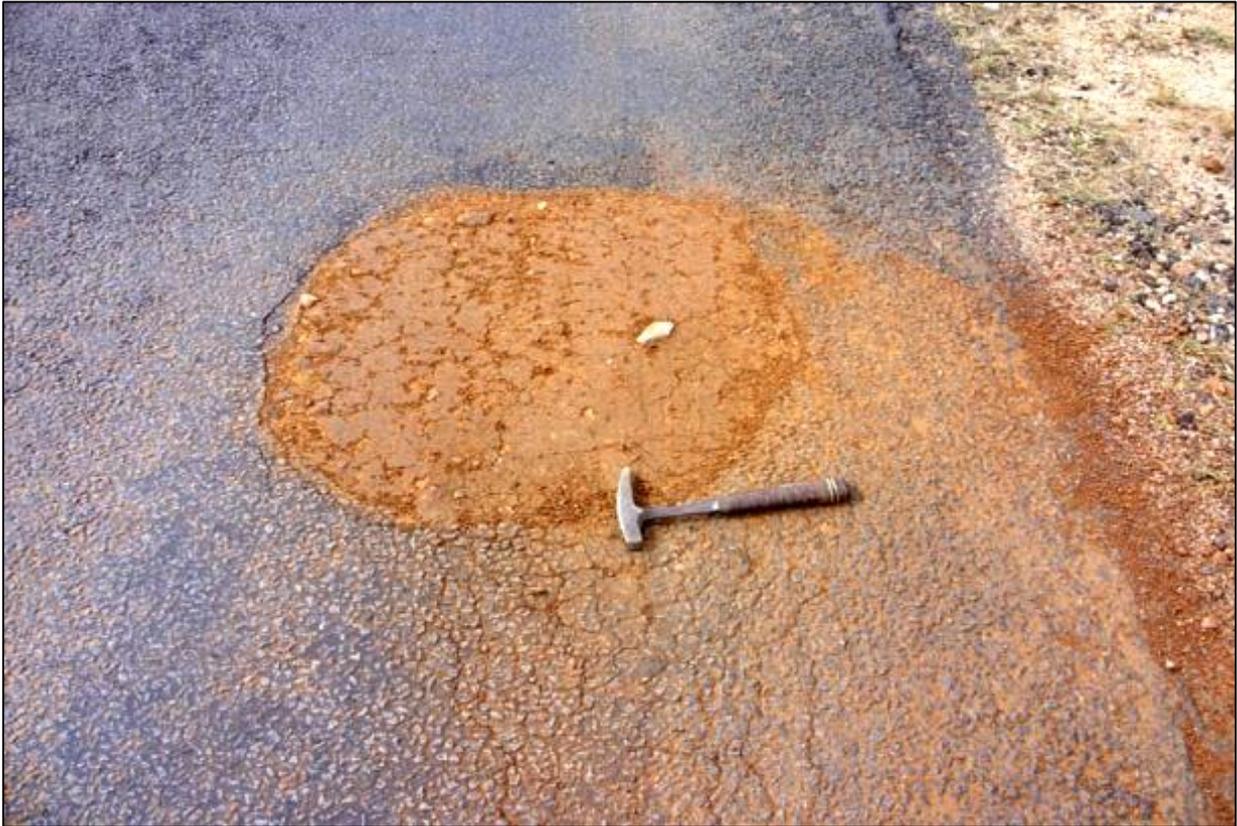
Figure 2.9: Poor Pothole Maintenance

Heavy traffic loading, usually above the limits of the road-surface design, results in load deflections through the road structure. When these deflections are repeated over a period of time, they result in surface cracking and water seepage (Fetch, 2011).

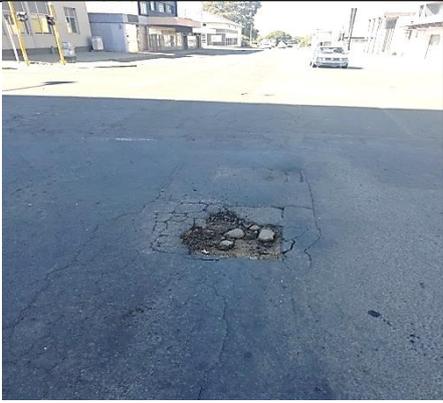
Type of potholes based on degree and extent			
Road	Average degree	Average extent	Picture
Nelson Mandela Drive	1	1

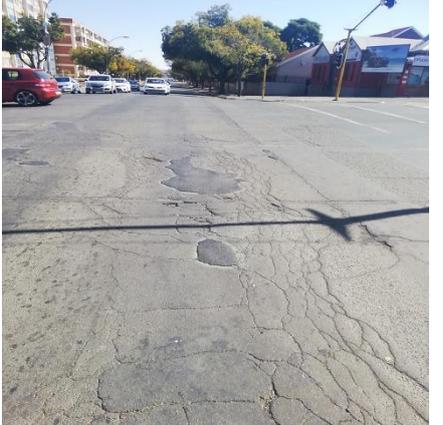
Zastron Street	1	1

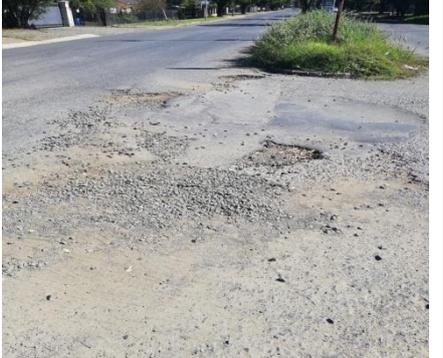
Gladstone Road	3	3

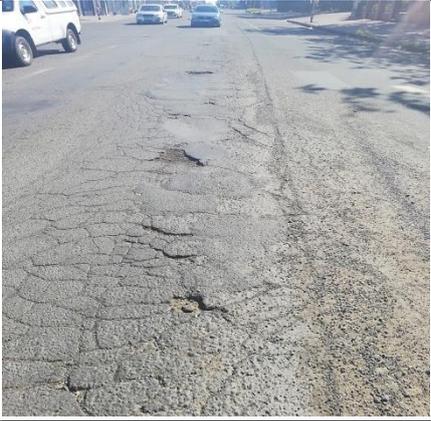
Bergstraat Street	<p>3</p>	<p>3</p>

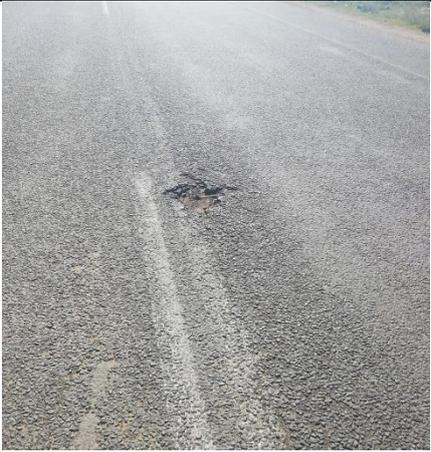
Meadows Road	<p>1</p>	<p>0</p>

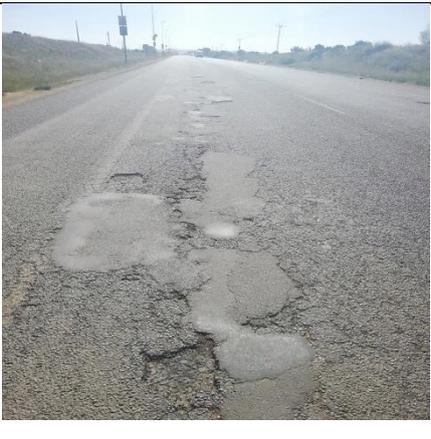
Dewetsdorp Road	<p>3</p>	<p>5</p>

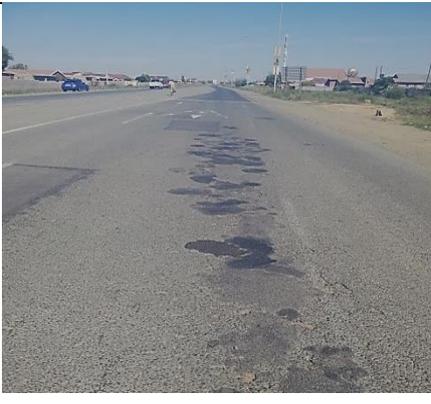
M10 Road	<p>3</p>	<p>5</p>

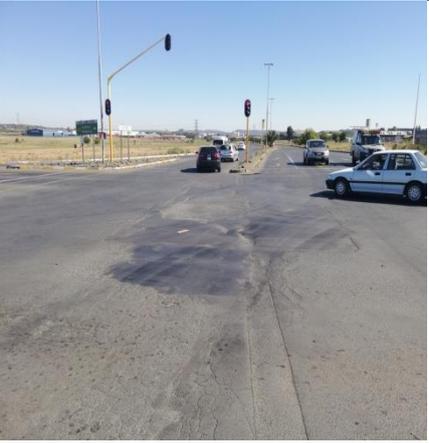
<p>Church Street</p>	<p>3</p>	<p>3</p>

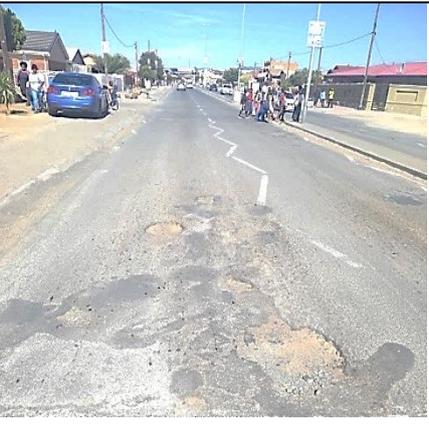
<p>Moshoeshoe Street</p>	<p>1</p>	<p>3</p>

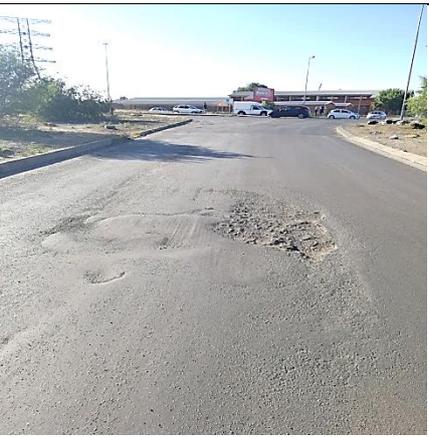
<p>Robert Burns Street</p>	<p>5</p>	<p>3</p>

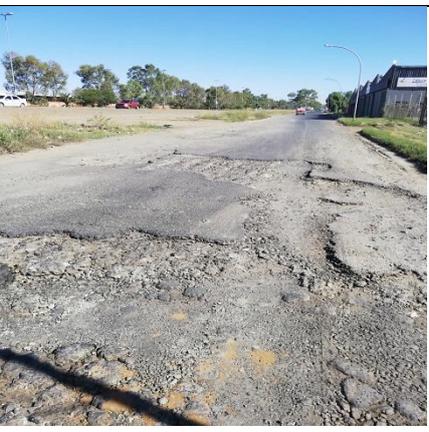
<p>Cnr Church St and Hartley St</p>	<p>5</p>	<p>5</p>
