SUSTAINABLE APPROACH TO UPGRADE LOW VOLUME ROADS IN PETRUSVILLE

E. MCKENZIE & M. MOSTAFA HASSAN

SURT RESEARCH GROUP, CENTRAL UNIVERSITY OF TECHNOLOGY,
FREE STATE

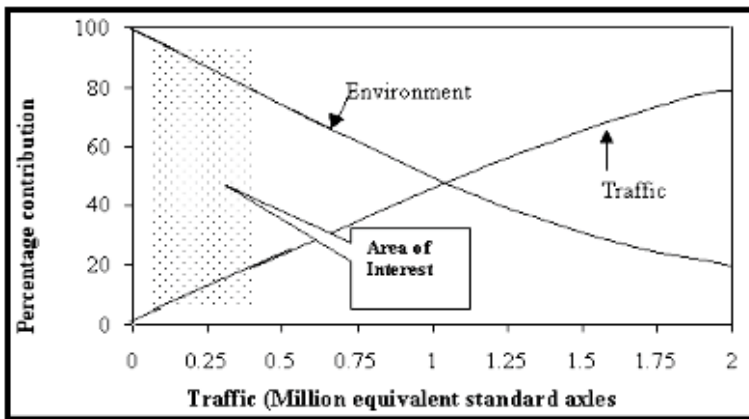
Fig.2: Effect vehicle loads and the environment has on the pavement's performance (Pinard, 2011).

More than fifty years ago a 'rule of thumb' was established that stated roads can be upgraded from earth to gravel if the daily traffic exceeds 50 vehicles per day (vpd). The rule also stated that gravel roads can be upgraded to sealed standard if the daily traffic equals to 200 vehicles per day (Gourley et al 2002). In developed countries like the USA, low volume roads are defined by roads carrying 400 vehicles per day. In African countries it is defined by a road that carries approximately 300 vehicles per day which is about 1 million equivalent standard axles. Yet the above definition of low volume roads are very rarely used (Pinard et al, 2015). As seen in figure 2 it is clearly evident that pavement deterioration for high volume roads (>0.5 million equivalent standard axles) is caused by vehicle loads rather than the environment. For roads carrying less than 0.5 million equivalent standard axles environmental factors need to be considered when designing low volume roads. Main environmental factors affecting low volume roads are the moisture changes in the pavement, fill and subgrade (Pinard, 2011). That is why the surfacing option should be carefully considered to eliminate the effects the environment (temperature and rainfall) will have on these roads.

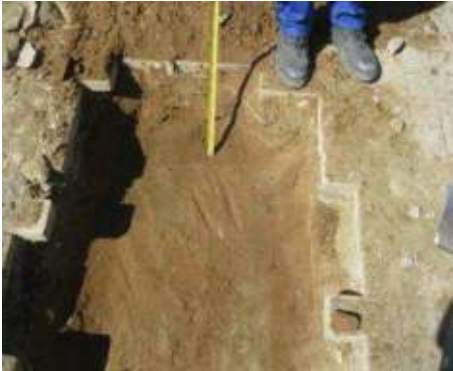
Fig 3: One of the test pits for Petrusville (Koppie Street)

In 2015 visual inspection along the road indicated that no discernable distress of the pavement occurred in the form of surface and base failures. Results in the next section clearly outlines that the sub-base is still in a sound condition and has not suffered from shear deformation through vehicle loads. This is also an indication that the drainage on all the roads was sufficient were properly constructed.

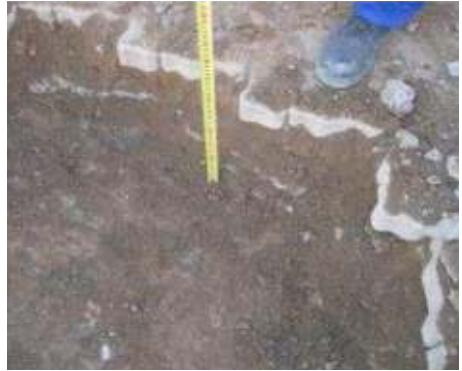
Fig 4: One of the test pits for Philipstown (Street 2)
