An Investigation into the influence of ageing components on medium voltage network configurations in Semi-Urban areas

Dissertation submitted in fulfillment of the requirements for the degree:

Master of Engineering

Central University of Technology, Free State

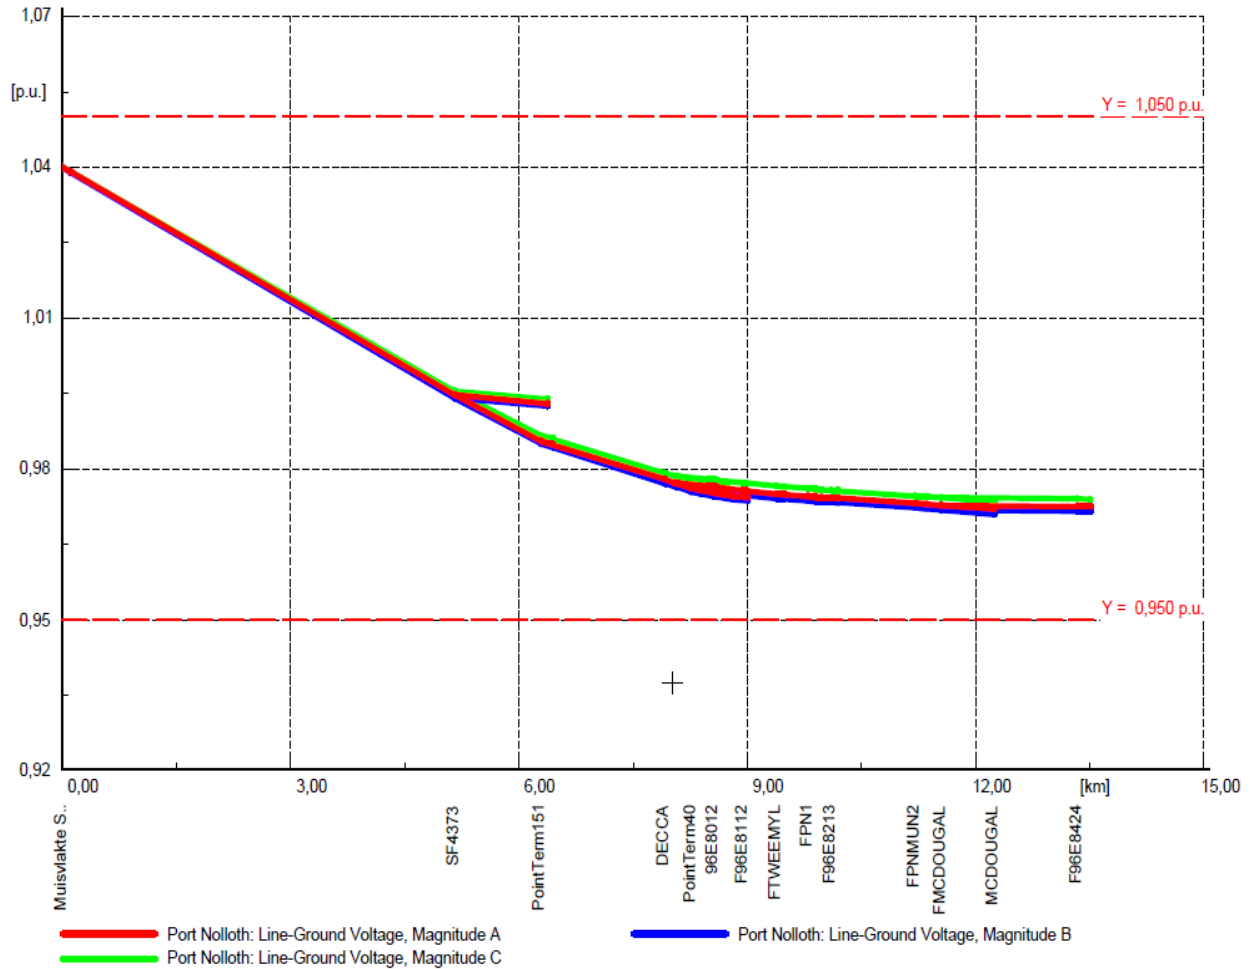
Figure 4.14: Muisvlakte-Port Nolloth 11kV overhead line voltage profile

The results of the modelling of the Muisvlakte-Port Nolloth overhead line on Power Factory with the correct scaling and line characteristics are shown in Figure 4.14. The voltage profile for the Muisvlakte-Port Nolloth 11kv overhead line was found to be within the voltage limits, with the lowest being just below 0.98p.u.

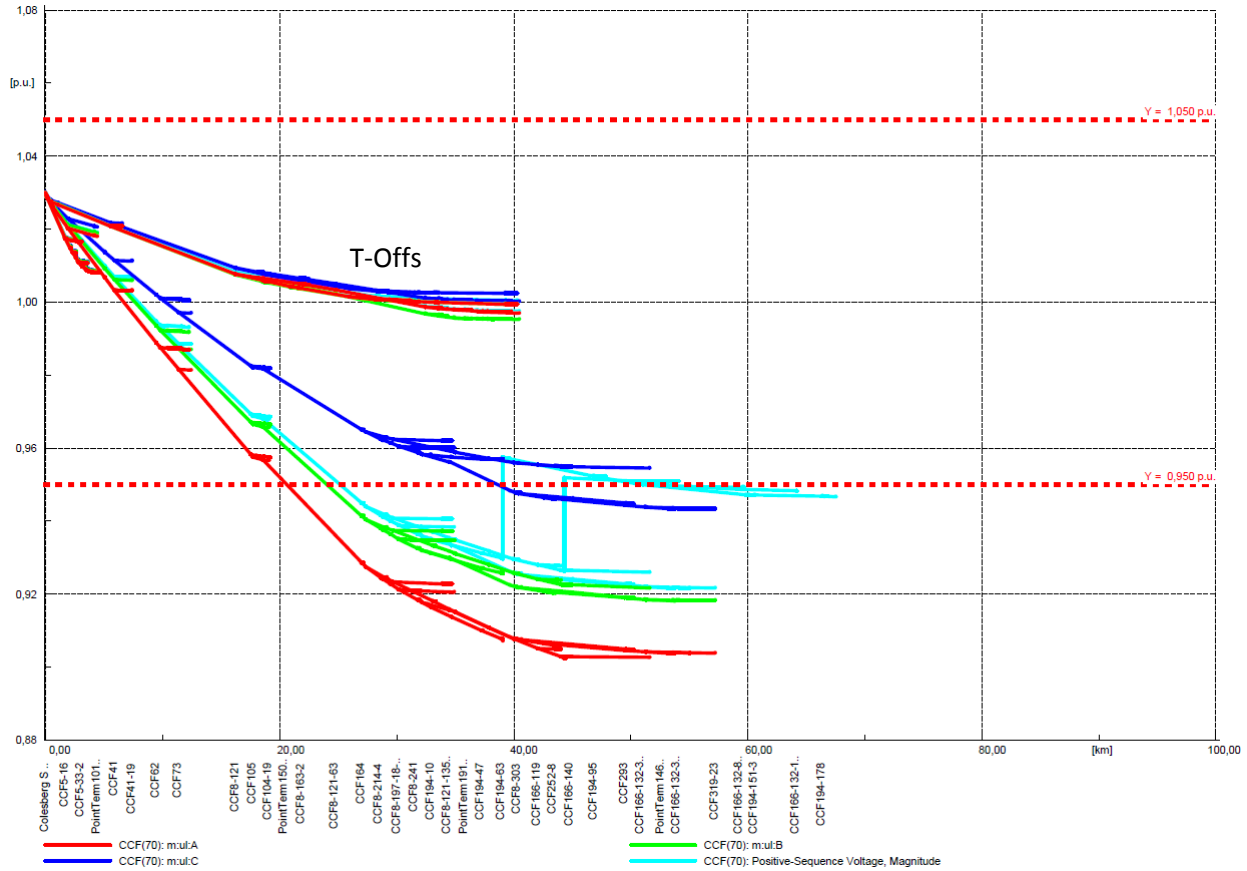
Figure 4.16: Colesberg-Coleskop 11kV overhead line current voltage profile after the simulation

As noted previously, the total length of the line including all the T-offs are approximately 300km. Due to its length, after approximately 20km from the source of supply, the feeder experiences a volt-drop below the limit of 95%. The voltage profile of the line after the simulation is portrayed in Figure 4.16.

When the voltage reaches customers 40km away, the voltage has dropped significantly below the limit, which is not in accordance with NRS48-2 [46]. The red, blue and green lines on the graph indicate the phases on the three-phase system. The light blue line indicates the voltage level in the SWER network system. The SWER line goes up because of the tapings of the SWER transformer. Depending on transformer tapping, the voltage in the SWER network used in most lines in the Northern Cape can either be 19kV or 23kV. In comparison to the green line, the blue and red lines have the lowest voltage drop. The voltage limit is indicated by the broken line at 0.95p.u. and 1.05p.u.

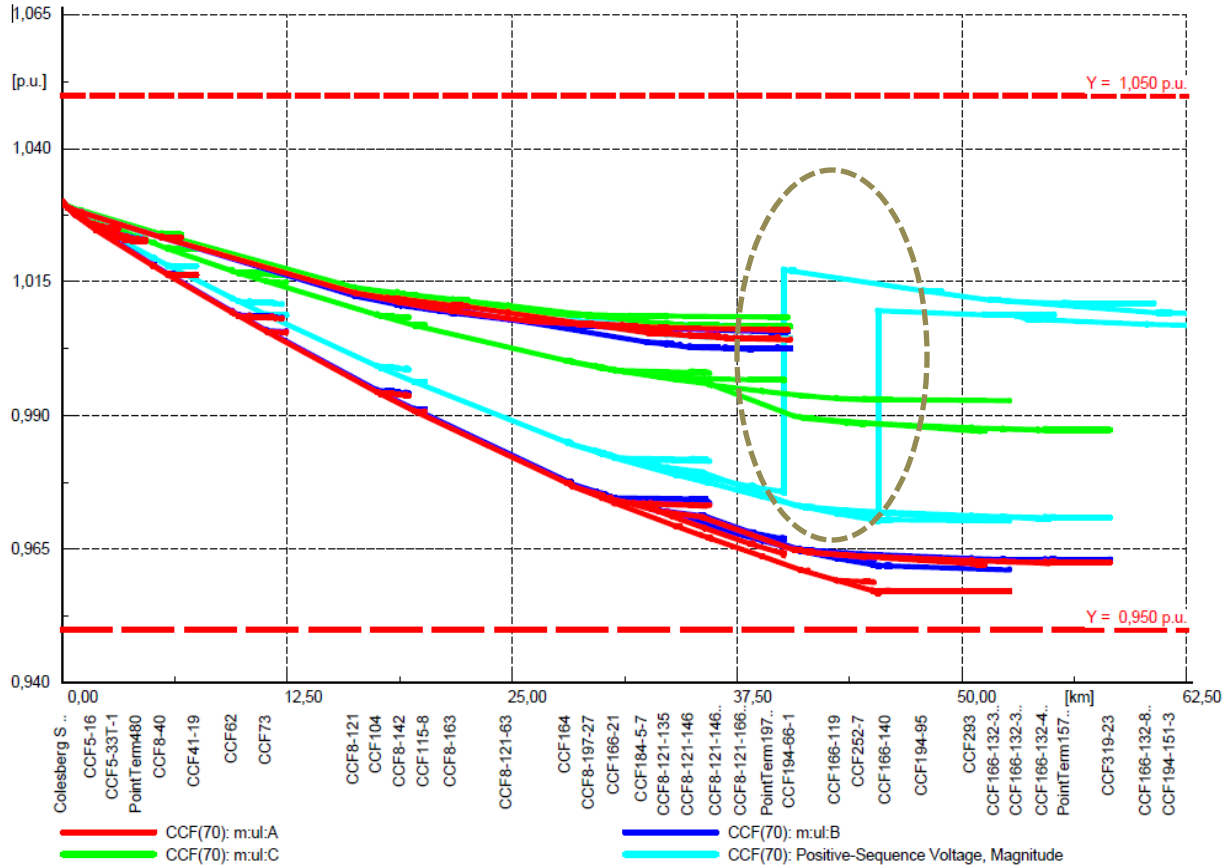
Figure 4.17: Colesberg-Coleskop 11kV overhead line voltage profile after backbone conductor upgrade simulation

The voltage profile of the line after the conductor on the main backbone was upgraded from Mink conductor to Hare conductor is depicted in Figure 4.17. The voltage is just above the voltage limit of 0.95p.u as defined by the grid code. The dotted line indicates the voltage limits in per unit values. The two spikes, which are circled, indicate the SWER network voltage. The red, blue and green lines represent the phases in a three-phase network.

The results demonstrated an improvement in the voltage profile of the line after the simulation. The voltages were within the required limits even though at 50km the voltage was closer to the limit. The graph also reveals that as much as the system is three-phase, the voltage profile for each phase is different possibly because some of the phases have more loads connected to them. Figure 4.17 reveals that the blue and red phases were affected mainly by low voltage.

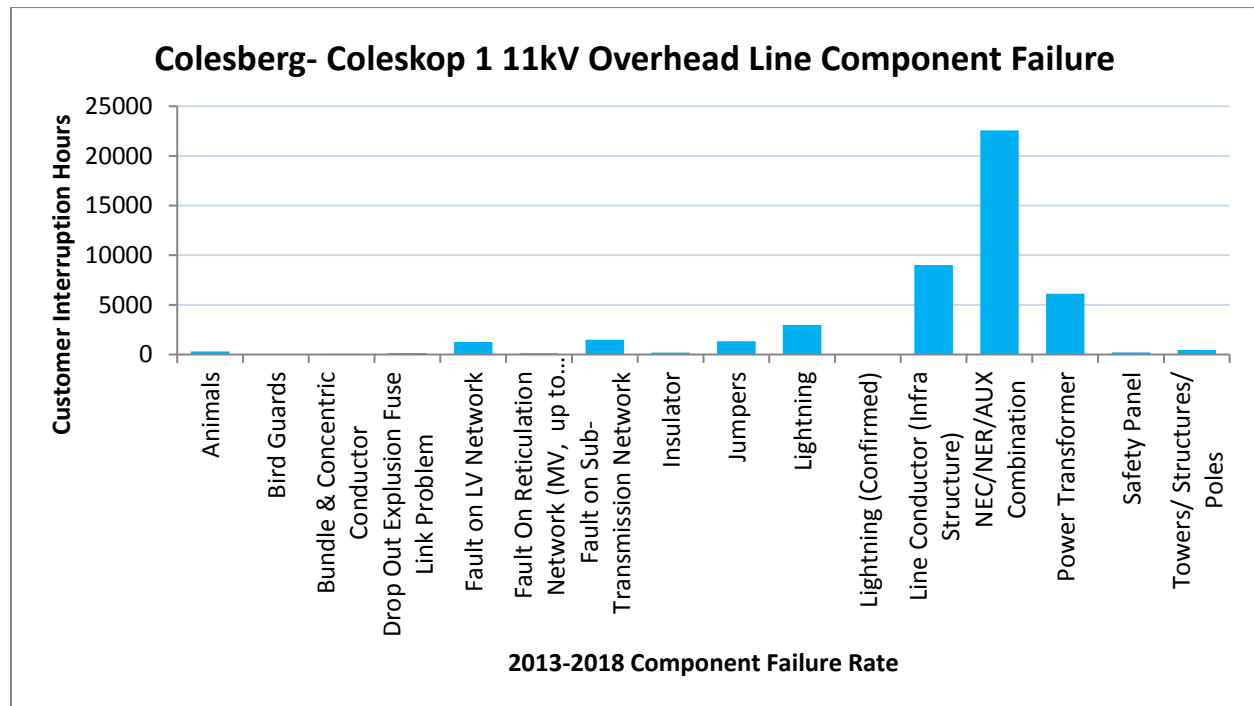
Figure 4.33: Colesberg-Coleskop 1 11kV overhead line component failure

The main backbone of the line is made of Rabbit conductor, which caused most of the failures on this network. A NEC/NER/AUX fault usually occurs on SWER networks and is mainly caused by earthing. The NEC/NER/Aux (SWER network section) caused the most CI on the Colesberg-Coleskop 11kV line. This line consists of a Squirrel conductor, which is a small conductor of 20mm². It usually burns if the load is too large thus contributing to the number of CIH. Power transformers are the third highest contributor to CIH; in this case, pole-mounted transformers located in Kuyasa. Three factors, depicted in Figure 4.33, contributed significantly to CIH.

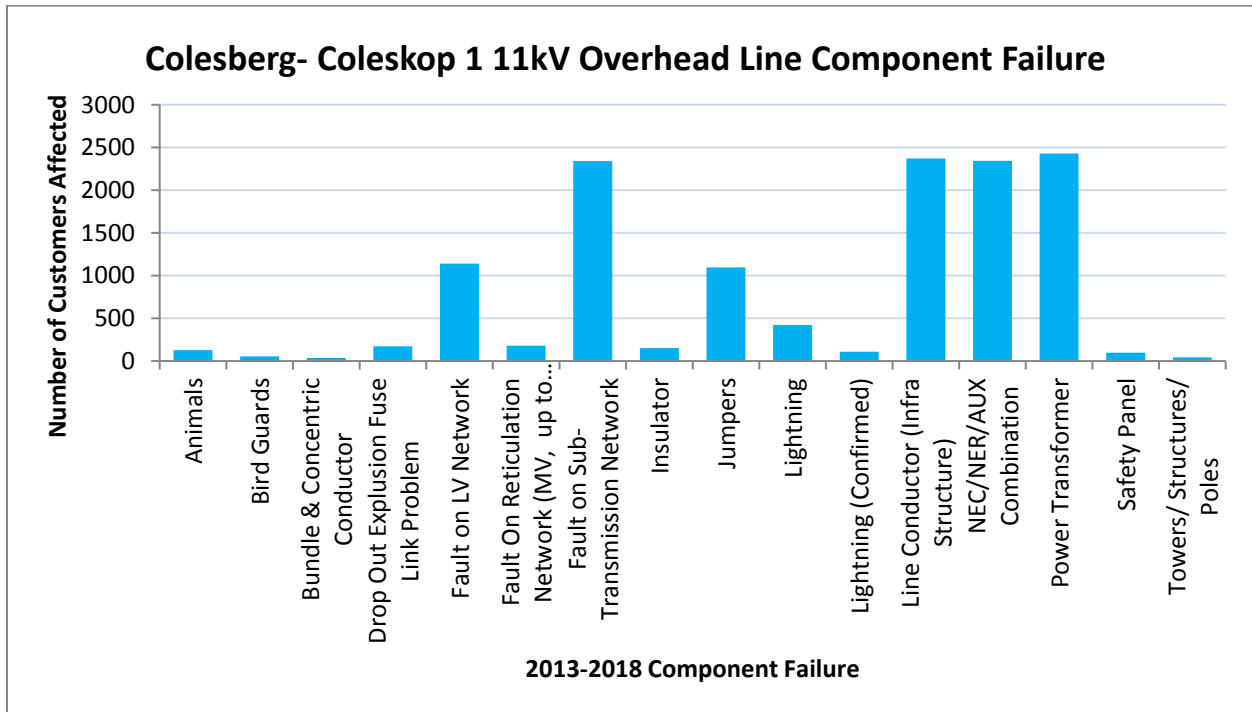
Figure 4.34: Colesberg-Coleskop 1 11kV overhead line number of customers affected

A study of Figure 4.34 reveals that power transformers are one of the leading factors that cause many interruptions on the network. NEC/NER/Aux, which is more evident on the SWER network, was also the cause of many interruptions. Because of the SWER network, most of the conductor failures on this section of the line are due to the size of the conductor. High thermal loading causes damage on the conductor. This also applies to the jumpers, which contributed the most to supply loss. Transmission networks where from where distribution networks are supplied also contributed to interruptions. The faults on the LV network mostly occur in Kuyasa with its many customers.

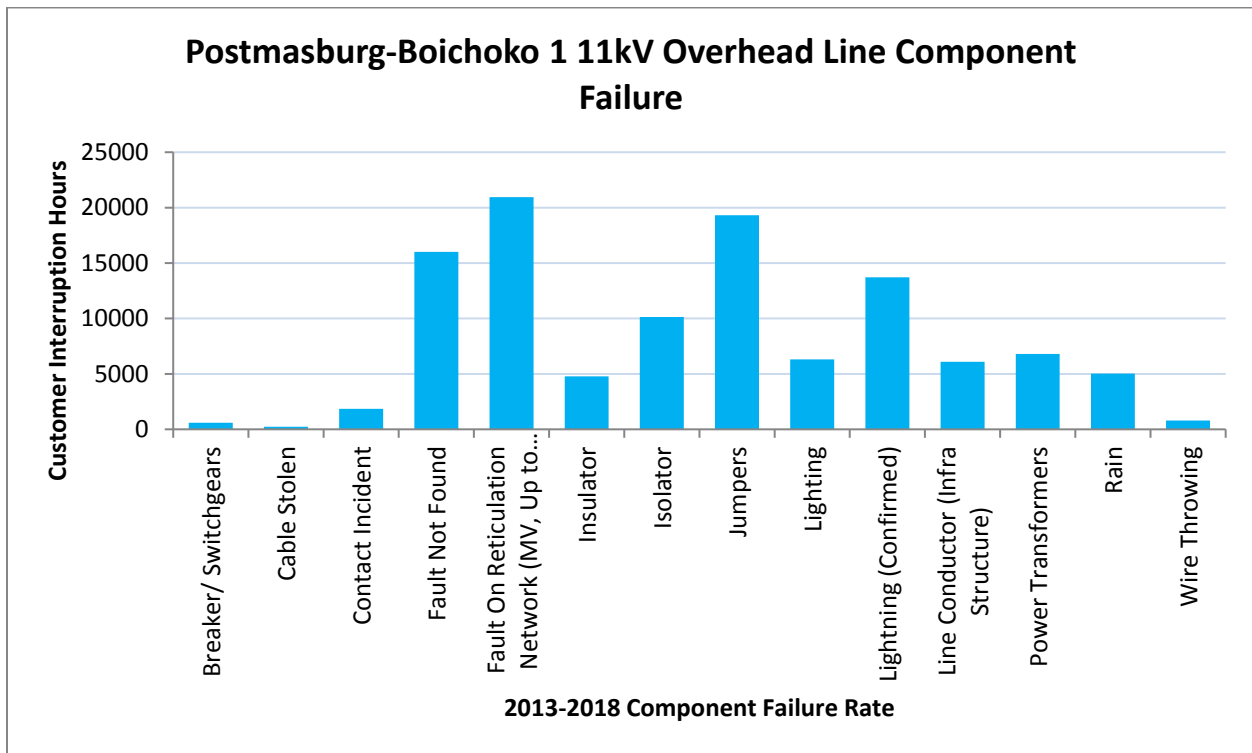
Figure 4.35: Postmasburg-Boichoko 1 11kV overhead line customer interruption hours

The components that contribute the most to CI in the Postmasburg Traction-Boichoko 11kV network are portrayed in Figure 4.35. The data on the graph were recorded over a five-year period. Most of the faults originated from the MV network in Newtown. These failures contributed to most of the supply interruptions on this network. The component that contributed the most to the number of CIH were faults on the feeder including fallen trees, people throwing stones on the network, broken poles and vehicle collisions.

Jumpers contributed the second most to CIH. The reasons jumpers fail include using incorrect joints, burn due to excessive thermal loading and corroded joints. Faults that occur on the line and cannot be tracked contributed the third most to CIH. In most cases, the ARC (auto-recloser) usual clears the fault before the operator can be dispatched to find the fault, report and fix the fault. Minor faults include branches of trees that fall, faults on the line, flashovers between two phases and fall off, which involves someone throwing a wire over the line, which falls off. Most of the component failures contributed to less than 10 000 CIH on this feeder.

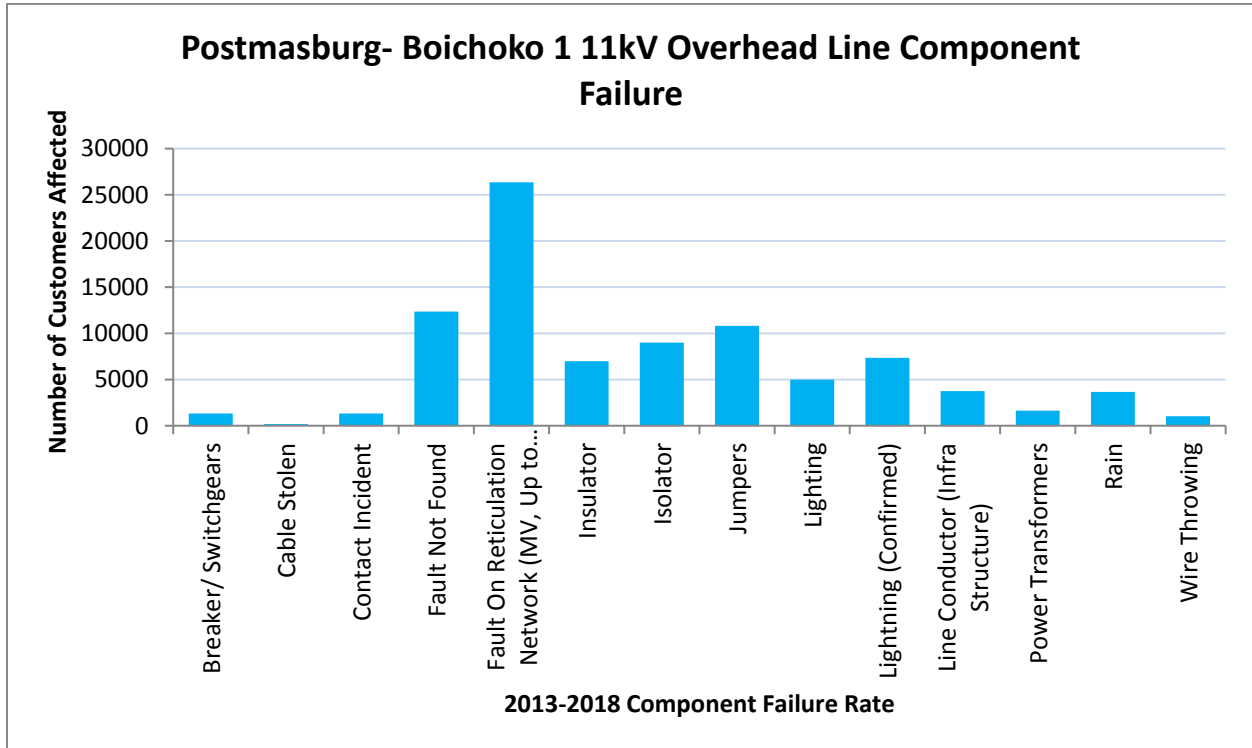
Figure 4.36: Postmasburg-Boichoko 11kV number of customers affected

The number of customers interrupted because of the faults that occurred on the line is portrayed in Figure 4.36. The data were recorded over a five-year period. Faults on the reticulation network affected the customers the most. Most of these faults occurred at anywhere along the line; when in the bush, poles were burned down. Faults on the reticulation network contributed to over 25 000 customer interruptions over the five-year period. This feeder had approximately 3 000 faults, which affected some customers on more than three occasions.

The y-axis in Figure 4.36 indicates the actual number of customers that were affected by the interruptions over the five-year period. These faults were caused by general faults including the clashing of conductors, trees falling on the line, conductor snapping and high transient faults. Jumpers followed by lightning contributed the most to CI on this line. The components failures, but not general faults affected less than 15 000 customers.

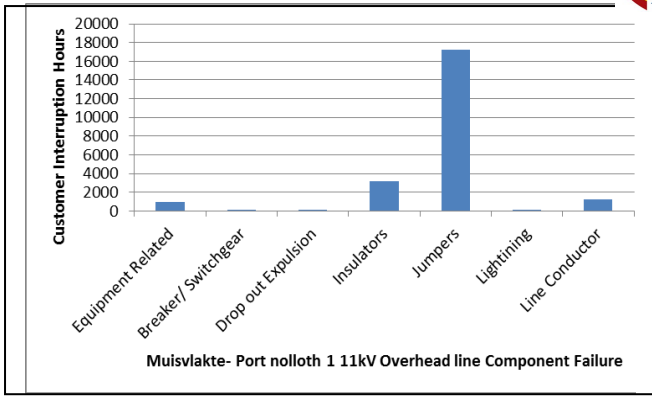
Fig .6. Muisvlakte- Port Nolloth 11kV OHL Component failure rate

Due to salty moist generated from the ocean, most of the components are exposed to rust. Muisvlakte- Port Nolloth 11kV feeder was constructed using different types of conductors with the different current rating. The information indicates how many times did the components fail on the line and how many customers were affected due to the specific component that failed. From both graphs, it can be observed that the highest contributor for both customer interruption hours and customers interrupted are jumpers, Followed by structures which are poles. Most of the jumper failures occur because of the rust on the joints which is due to most coming from the coast. Rust in this area affect most of the exposed components made of steel with an example shown in Fig.7. The picture was taken on the Recloser point just outside Muisvlakte Substation in Port Nolloth.

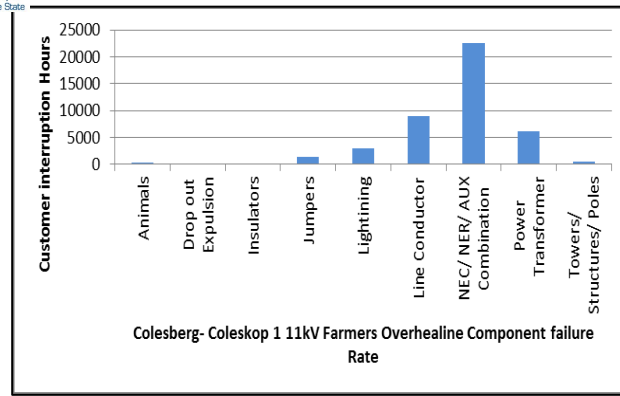
Fig .8. Colesberg- Coleskop 1 11kV Components failure rate.

Colesberg- Coleskop 1 11kV Overhead line consists of two different networks which is three phase network as well as SWER (Single Wire Earth Return) network. SWER is usually used in the remote areas that consist of few customers. According to the graph above, most faults or interruptions occur on SWER transformers and Auto-Reclosers, and most of those faults are due to Earthing with corroded or broken earth rods. Fig. 8 also shows the failure rate of line conductor which mostly occur on the SWER conductor due to the type of conductor used. Most of the sections on this line make use of Squirrel type conductor which is a thin conductor used previously on the customers with lower load specifications. During hot conditions, the conductor stretches and increases the sagging of the conductor which affects the elastic strength of the conductor. Medium voltage transformers or pole mount transformers causes' interruption because of heat generated in the transformers due to load increase. During hot weather conditions, the ambient temperature can also affect the heat generated in the transformer. When the pole mount transformer is overloaded, the pressure in the tank increases and causes leakage of oil on the bushing and the tank itself as shown in Fig. 10.

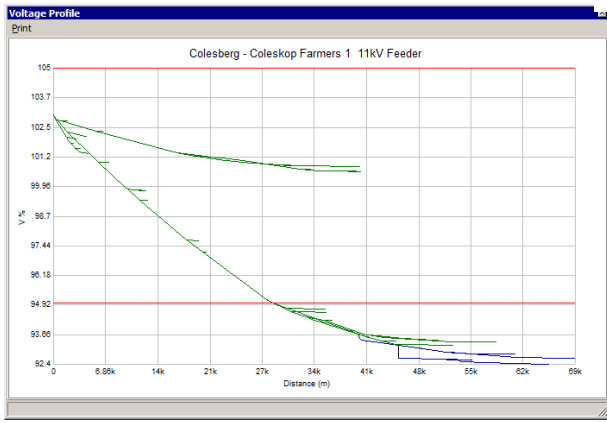
Fig. 9. Colesberg- Coleskop 1 11kV Voltage Profile.

The total length of the line including all the T-offs is more ± 300 km as indicated on the background information. Due to the length of Colesberg- Coleskop overhead line, after ± 27 km from the source of supply, the feeder experiences a volt- drop which is below the limit of 95% as indicated in Fig. 9. Due to this voltage drop on the line, the line does not have enough capacity to connect new customers. The most affected customers due to the low voltages are further away customers and the customers supplied from SWER networks. All the cycles on the graph indicate the T-Offs from the main line.

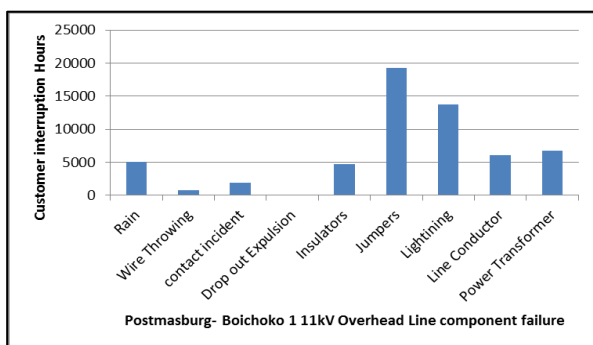
Fig. 11. Postmasburg-Boichoko 1 11kV Component failure rate

The graph above shows the most contributors when it comes to customer interruption hours (CI). The data on the graph was recorded over a period of three years and most of the faults that caused the most interruption hours came from the MV network in the Township. The most significant contributor that affected most customers is the faults on the

Postmasburg area is highly affected by lighting which has a negative impact on the conductor and the jumpers on the line. Temperatures in Postmasburg Area range from 17° C in June to 32° C in January, with more rainfall happening during summer annually. As observed from Fig. 11, Jumpers fail because of the hotspot created over a certain period of time. When the current supplied on the conductor exceed the rated current of the conductor, excessive heat is generated causing the conductor to fail at some point. The cause of jumper failure on Fig. 11 is mostly due to the loose joint that connects the jumper to the main line, and in most cases, the size of the joint is not compatible to the size of the conductor used.
