Fracture mechanisms in the as-built and stress-relieved laser powder bed fusion Ti6Al4V ELI alloy

A.M. Vilardell^{a,*}, G. Fredriksson^a, I. Yadroitsev^b, P. Krakhmalev^a^a Karlstad University, Department of Engineering and Physics, Karlstad SE-651 88, Sweden^b Central University of Technology, Free State, Department of Mechanical and Mechatronic Engineering, Private Bag X20539, Bloemfontein 9300, South Africa

The influence of a stress-relief treatment on impact and fatigue properties of Ti6Al4V ELI samples manufactured by laser powder bed fusion was analyzed. The heat treatment resulted in removal of residual stresses, coarsening of needles and formation of precipitations between needles. In both, impact and fatigue tests, crack development was correlated to microstructural features. Fracture analysis was carried out by means of optical and electron microscopy to reveal the influence of microstructure on crack development. Ductile fracture was the dominating fracture mode at impact testing. Pore formation and coalescence were the main crack formation mechanisms. The microstructural changes led to a decrease in impact toughness after heat treatment. Presumably, this was a result

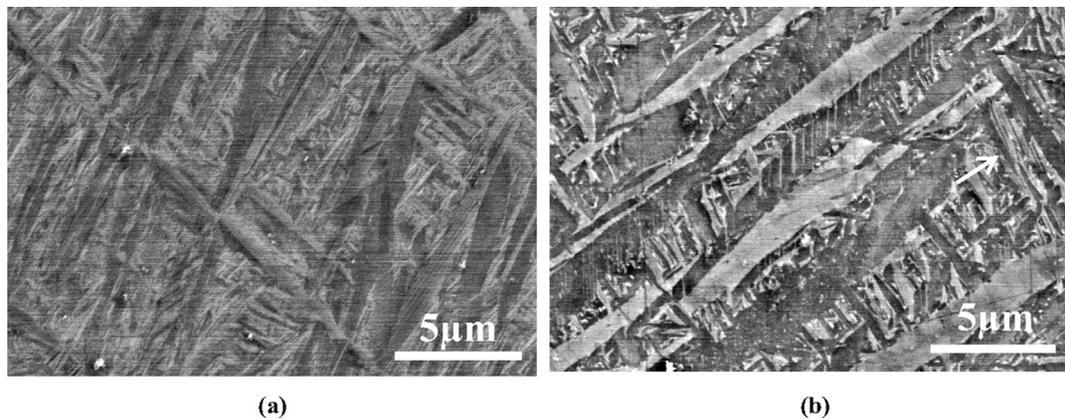
Fig. 1. SEM micrographs in backscattered electron mode of (a) AB and (b) SR LPBF Ti6Al4V ELI specimens.

Fig. 1a and b shows the needle microstructure of AB and SR materials, respectively. After the SR treatment, an increase in size of the martensitic needles can be observed. The average thickness of the needles was measured to be of $0.4 \mu\text{m}$ and $1.1 \mu\text{m}$ for AB and SR specimens, respectively. Additionally, the microstructure has changed. After SR treatment spot like precipitations between the needles appeared, but EBSD did not show any evidence of β -phase (Fig. 2).

In the present investigation, changes in morphology of the needles after stress-relief heat treatment were observed by electron and optical microscopy, Fig. 1a and b. The average thickness of the needles increased and small precipitates appeared between the needles. However, EBSD did not detect any β -phase (Fig. 2). Often, similar precipitations have been reported after heat treatment [19,22,24]. At the same time, small white precipitations between α/α' needles were visible in the as-built specimens, but also in as-built specimens [25,26]. The precipitations found in as-built specimens were located between α/α' needles and have been identified as α -phase, and called “ α rods” and “ α dots”

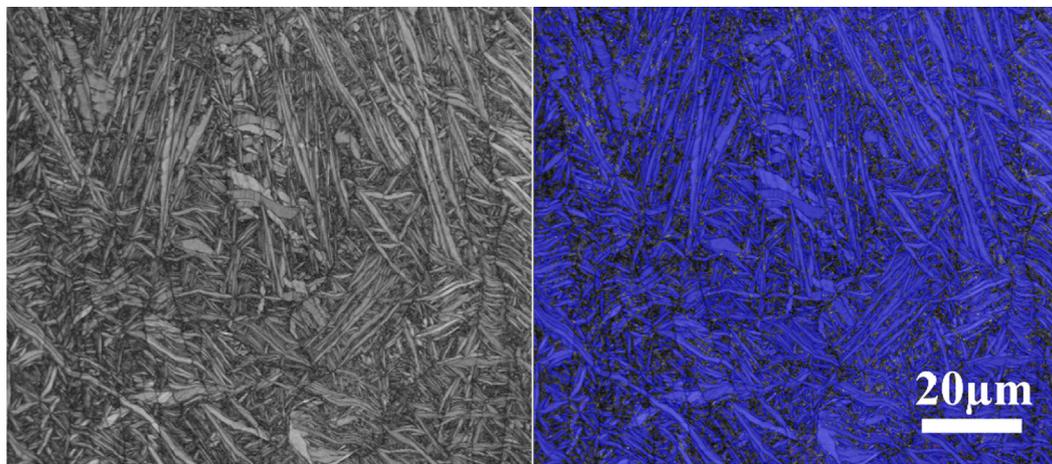
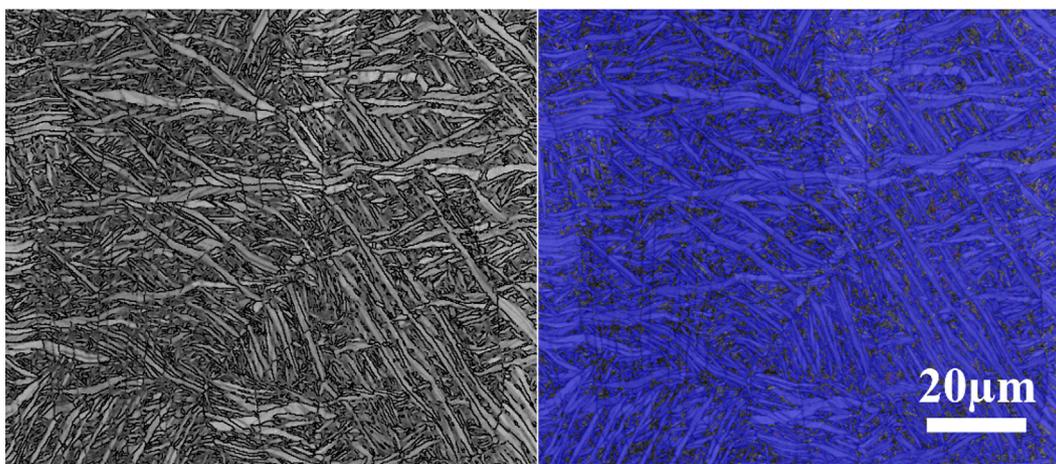
Fig. 2. EBSD results showing band contrast (left) and phase contrast (right) micrographs of (a) AB and (b) SR samples. (α/α' -phase: blue color; β -phase: red color). (For interpretation of the references to color in this figure legend, the reader is referred to the web version of this article).

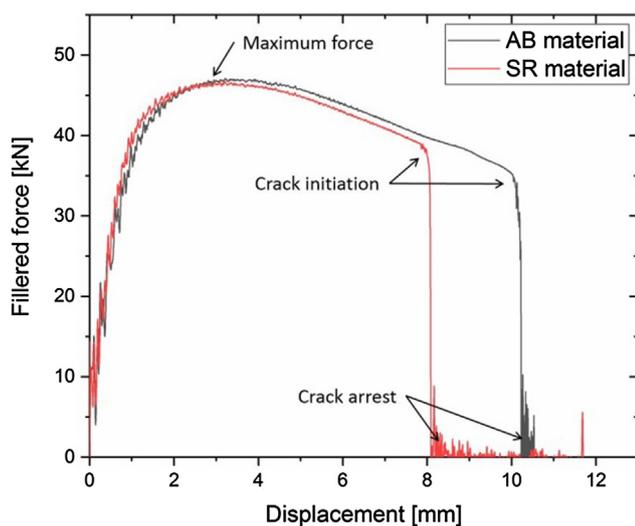
Fig. 3. Force-displacement curves of vertical AB and SR LPBF Ti6Al4V ELI specimens.

The characteristic force-displacement curves of each specimen are shown in Fig. 3. After sever plastic deformation, crack initiation and crack arrest points can be differentiated according to the standard specification ISO 14556 [15]. The energy absorbed by the material during the impact is described as the area under the force-displacement curve.

Table 1 shows the force and displacement values, as well as the absorbed energy during the impact at crack initiation and arresting points. The results show that the SR material absorbs less energy before crack initiation ($W_{iu} = 332$ J) than the AB material ($W_{iu} = 416.3$ J),

thus reaching higher displacement due to higher plastic deformation. Although both materials show a crack arresting point, the curves mainly show an unstable crack propagation by having similar crack initiation and crack arresting energy values.

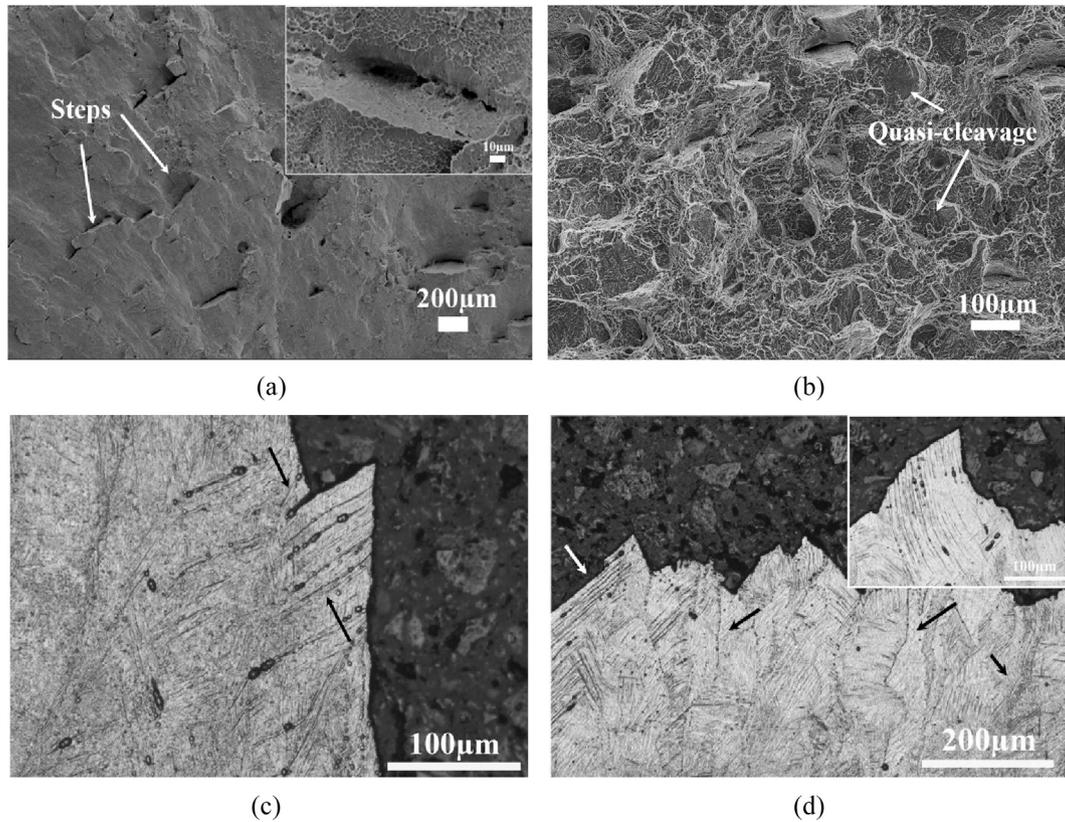
Fig. 4. SEM micrographs of fracture surface morphology of (a) the crack initiation region (typical steps are marked with arrows and shown in the inset) and (b) the crack propagation region (quasi-cleavage regions are marked with arrows); (c, d) optical micrographs of cross-sections: (c) corresponding to (a), and (d) corresponding to (b). The black arrows indicate the formation and coalescence of pore (c) between needles and (d) at prior β grain boundaries. The white arrows indicate the quasi-cleavage regions from Fig. 4b.

In all cases, an area with high plastic deformation where the crack initiated, a fibrous zone where the crack propagated, and shear lips were observed. Fig. 4 shows SEM micrographs of the fracture surface regions of crack initiation (Fig. 4a), and crack propagation (Fig. 4b). In the region of crack initiation, severe plastic deformation, shallow dimples and coalescence of voids was observed. Formation and coalescence of micro-voids lead to the formation of “terraces” clearly visible in Fig. 4a, indicated by arrows. Micro-dimples indicate ductile fracture. Fig. 4b shows a SEM micrograph of the fracture surface in the crack propagation region. The fracture surfaces of both AB and SR specimens have a similar appearance and the same features were observed. In both cases, “terrace” features were found. This could be a result of quasi-cleavage fracture [4] due to an interaction of the crack with features of the microstructure.

Fig. 4c and d shows the cross-sections of the fracture surfaces of Fig. 4a and b, respectively. The formation and coalescence of pores at prior β grain boundaries (Fig. 4d) and between needles (Fig. 4c and d) can be observed. The propagation of the crack along the needles led to

the formation of the flat regions known as quasi-cleavage in Fig. 4d.

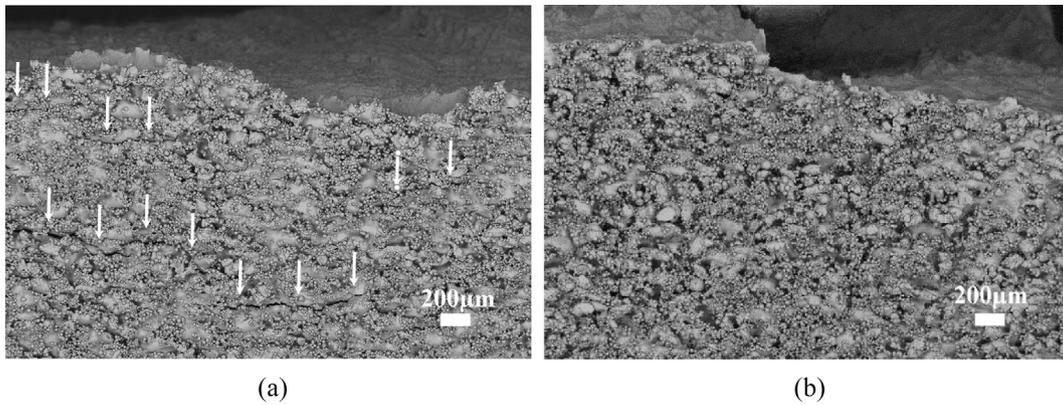
Fig. 5. Top surface areas of (a) AB and (b) SR specimens (Cracks indicated with white arrows).

In the AB specimens, the number of parallel cracks initiated during the test was high, Fig. 5a. In the SR specimens such parallel cracks were rarely observed (Fig. 5b). The difference could be explained by the relief of residual stresses in the SR specimens. Residual stresses are known to influence fatigue life of AM Ti6Al4V significantly. Studies reported that stress-relief treatment increased fatigue life by one order of magnitude [12]. Nevertheless, the final crack formed after the merging of sub-critical cracks is still irregular in the SR specimen as well. Although the stress was relieved, the surface roughness still led to multiple crack nucleation, which in turn resulted in deflections and irregularities at the fracture surface.

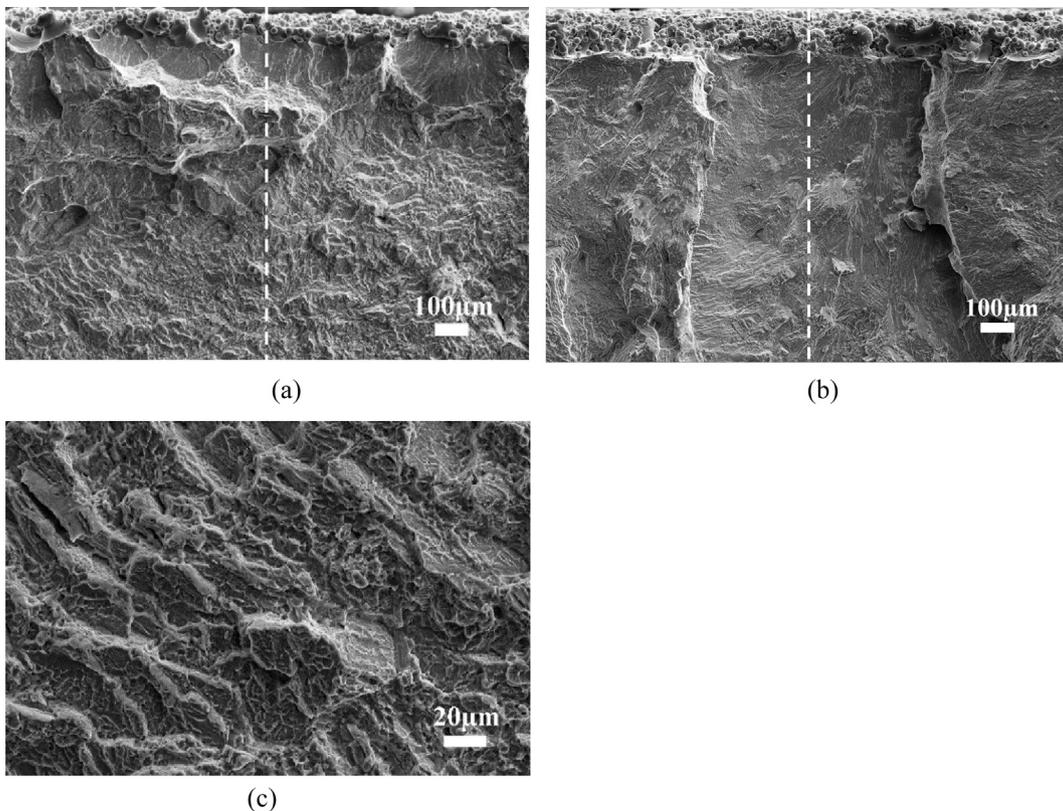
Fig. 6. SEM micrographs of crack initiation (a, b) and propagation (c) regions. The dashed line illustrates the direction of the cross-sections (in Fig. 7).

Both specimens show multiple crack nucleation (Fig. 6a and b). Additionally, cracks were found to initiate in parallel planes, thus merging and creating irregular fracture paths seen from the top surface (Fig. 6a and b). The crack propagation areas show irregular surfaces composed by dimples and quasi-cleavage features on both AB and SR specimens (Fig. 6c).

To investigate the interaction of the main crack with the microstructure, vertical cross-sections were made parallel to the crack propagation direction, as close as possible to the location of the main crack (Fig. 7), see dashed lines in Fig. 6. Observations of several cross-sections showed that the fracture surface in the crack growth area was smoother in the SR specimens than in the AB ones.

The study of fatigue crack nucleation and propagation carried out in this investigation, showed that cracks nucleated at the surface due to surface roughness. Surface roughness is known to influence fatigue life of AM Ti6Al4V significantly. In the literature, it has been reported that machining of the surface increased fatigue life substantially, especially at low stress amplitudes [12]. The deepest valleys and notches at the as-built surface of the LPBF Ti6Al4V specimens play a role as stress concentrators. The random distribution of these surface defects led to multiple nucleation of sub-critical cracks. These cracks grew parallel to each other at the loaded surface, Fig. 7. When these sub-critical cracks reached a critical size, they merged, but as they were not nucleated in the same plane, the finally formed crack is characterized by deflections and irregularities, Fig. 6b.

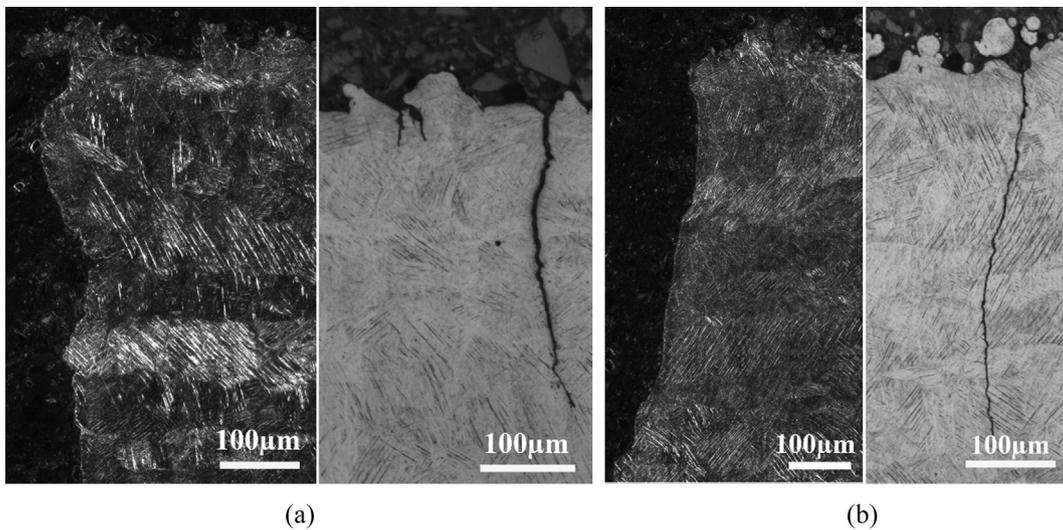
Fig. 7. Cross-section of (a) AB and (b) SR Ti6Al4V ELI fatigue specimens. Micrographs illustrate the main crack fracture and secondary cracks parallel to the main one.

From the crack propagation curves, illustrated in Fig. 8b, it is clear that the crack propagation rate is quite similar in both SR and AB specimens. However, the coefficient m in Eq. (2) is slightly lower for the AB material (Fig. 8b). The m values are 1.32–1.45 in AB and 1.37–1.58 in SR. Similarly, higher fatigue crack propagation rates in SR specimens were observed in LPBF Ti6Al4V ELI [9]. The fracture surfaces of the AB specimens were rougher than those of the SR specimens, Fig. 7.

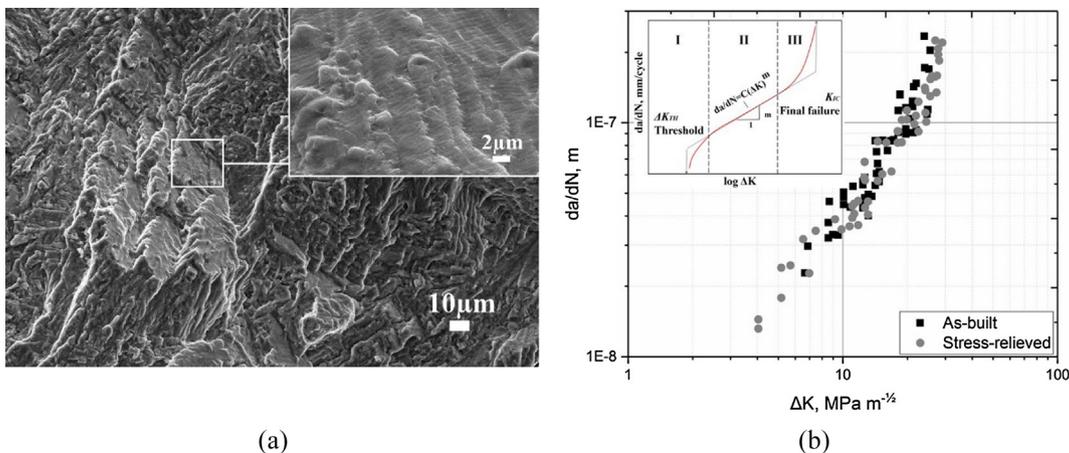
Fig. 8. (a) SEM micrograph of surface striations. (b) Fatigue crack propagation of AB and SR LPBF Ti6Al4V ELI specimens.

Crack propagation was estimated based on electron microscopy observations of the width of striations on the fracture surfaces in dependence on the crack length (Fig. 8a). The calculations of ΔK value

Fig. 8b shows the typical behavior of crack growth. The sigmoidal curves can be divided into three different regions, usually known as I, II and III (inset Fig. 8b). Within region I (where stress levels are low and/or the length of the cracks are small), the pre-existing cracks will not grow with the cyclic loads. In other words, there exist a threshold value (ΔK_{TH}) below which fatigue cracks will not propagate. Above the threshold value there is a linear region (regime II) in Fig. 8b until the fracture toughness value (K_{IC}) is reached and final fracture occurs. The
