OCCUPATIONAL EXPOSURE TO RADIOFREQUENCY ENERGY AND STATIC MAGNETIC FIELDS IN MRI UNITS IN THE PUBLIC SECTOR WITHIN MANGAUNG METROPOLITAN REGION

Thesis submitted in fulfilment of the requirements for the Degree

DOCTOR OF PHILOSOPHY:

Central University of Technology, Free State

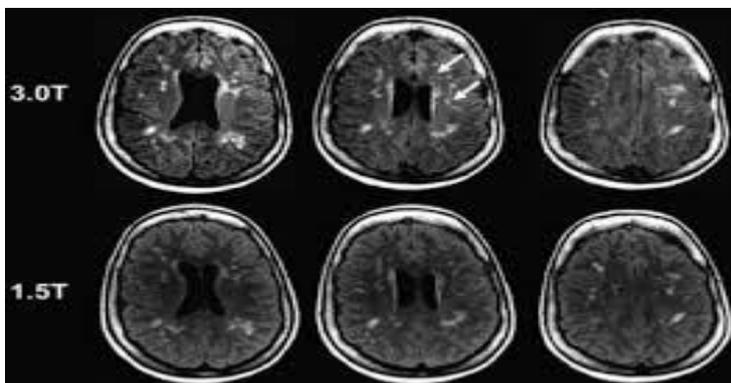
Figure 2.1: Structural imaging of the brain (Lymer, 2012)

emerged; functional studies such as metabolism, associated tissue movements, molecular diffusion, capillary perfusion, etc. (Hartwig *et al.*, 2018). Currently, MRI scanners with up to 3 T SMFs are used for common diagnostics and interventional procedures (Schaap *et al.*, 2013). MRI units exist in different forms, 7 T scanners are used in research facilities with the new systems up to 11.7 T introduced lately (Schaap *et al.*, 2013). MRI scanners do not expose the body to ionizing radiation; they use magnetic fields to obtain a detailed image (Ghadimi and Sapra, 2019). Magnetic fields in the MRI include switched gradient fields that are used for image coding and RF magnetic field created with a body coil that is integrated into the scanner (Hansson-Mild *et al.*, 2019) as well as SMFs emitted by the magnet. Figure 2.1 below represents an image produced by 1.5 T and 3.0 T MRI scanner.

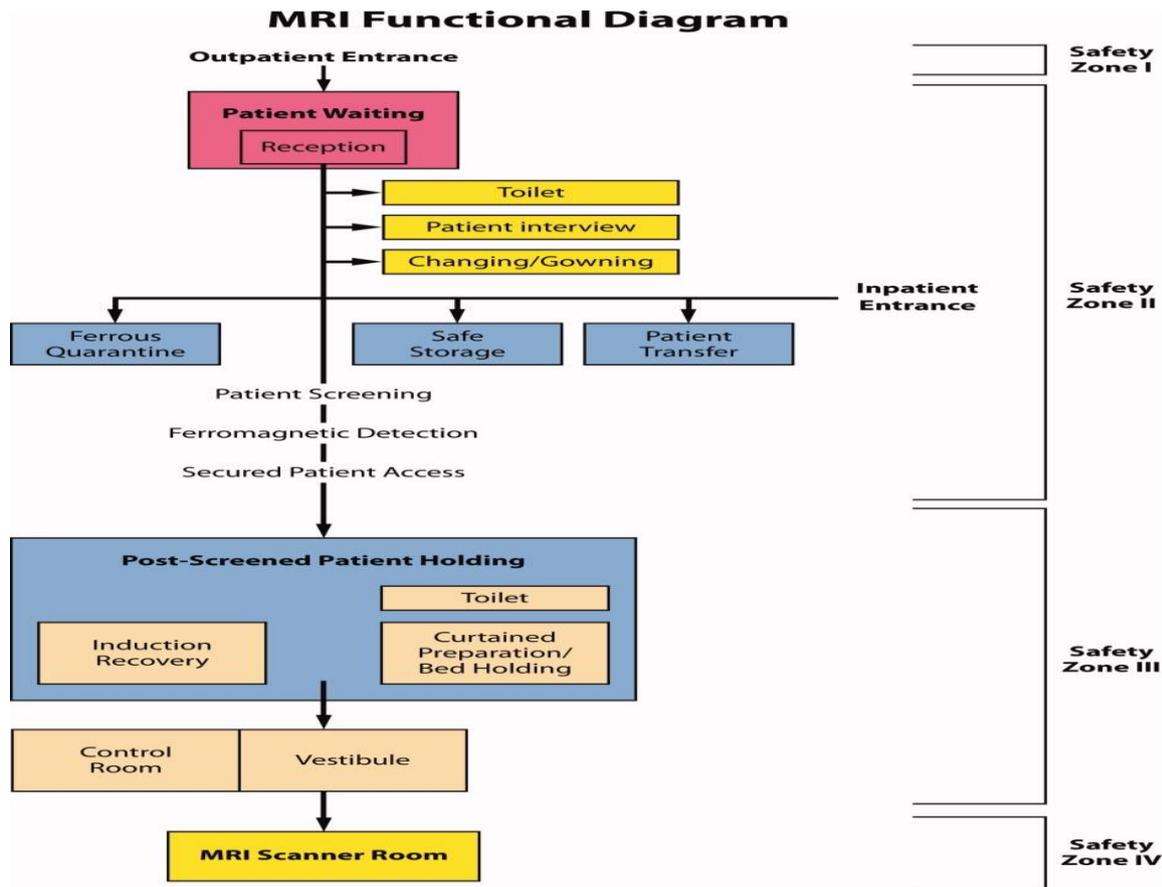
Figure 2.2: Four MRI safety zones (adopted from ARC, guidance document on MR safe practices; Kanal *et al.*, 2013).

The team of experts from the American College of Radiology (ACR) have developed guidance document that enforces strict safety adherence in the MRI units (Kanal *et al.*, 2013). To ensure safe practices in the MRI, the ACR defined trained MRI personnel according to different levels. According to Tsai *et al.* (2015), level one category of trained MRI personnel are regarded to have passed a minimum safety educational training to sufficiently protect themselves from safety accidents as they work in zone III. Level two personnel underwent extensive training and education in the broader aspects of MRI-related safety issues, while non-MR imaging personnel are those who do not comply with MRI safety instructions (Tsai *et al.*, 2015). Furthermore, the MRI units are clearly labeled according to four safety zones (Sammet, 2016) (Figure 2.2).

Zone I- This is an entrance to MRI facility, typically outside MRI units, and is freely accessible to the hospital general public. It is regarded as an area where magnetic fields poses no safety and health hazards.

Zone IV- this is the room where MRI scanner is located and there is a mixture of MRI-related EMFs. Ideally, this room is clearly demarcated as being potentially hazardous due to the presence of very strong magnetic fields (Kanal *et al.*, 2013). Zone IV is designed to contain the 5 Gauss (G) line of the fringe magnetic fields from the magnet.

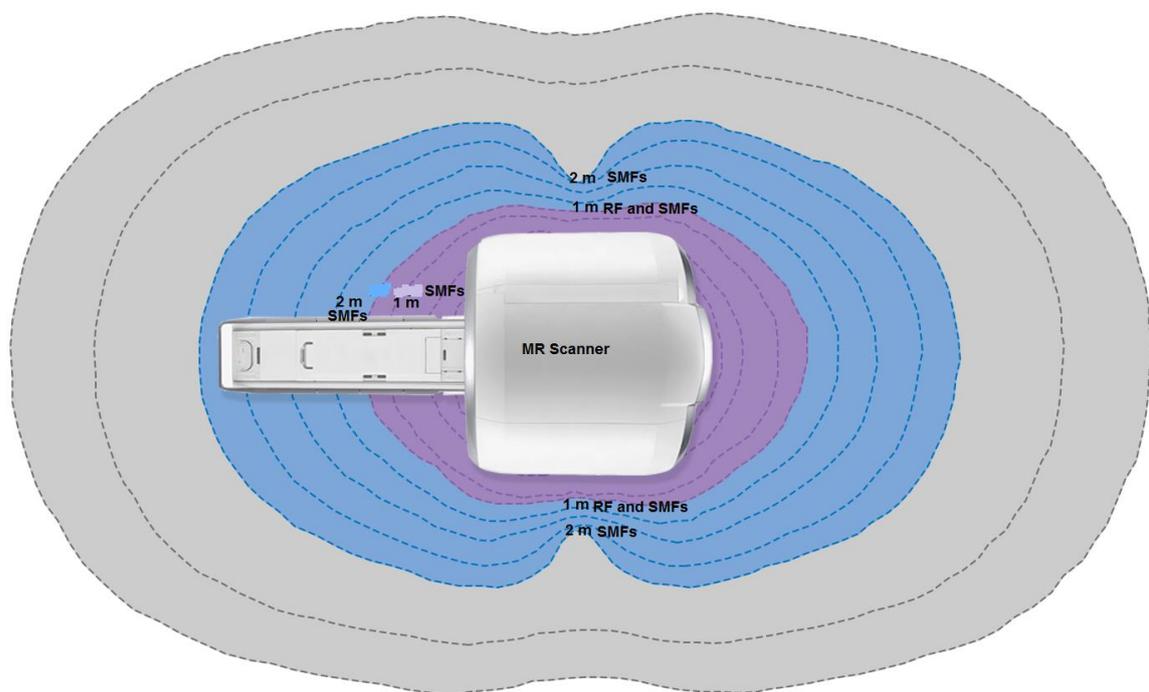
Figure 3.1: SMFs and RF magnetic fields sampling positions

Spot measurements were collected using distance as an exposure surrogate. Distance points were chosen as realistic exposure pathways where MRI staff move and perform duties around the scanners and also when entering zone IV. The purpose was to obtain exposure levels at different distances across MR zone IV. A manufacturer calibrated THM1176 3-Axis hall magnetometer was used to measure the exposure levels for SMFs. The magnetometer has a range from low fields to 20 T, DC to 1 kHz, and provide ± 1 % accuracy. Exposure levels were measured at a distance of 1 m and 2 m away from the scanner, similar to a technique used by Sakurazawa *et al.* (2003). The magnetometer height and distance: 1 m and 2 m on the front, left and right side (Figure 3.1) of the scanner were determined using a cloth measuring tape with linear-measurement markings. A THM1176 3-Axis hall magnetometer was positioned at a height of 1 m from the ground, with probe sensor facing the scanner magnet. The height was chosen to be representative where most of the MRI activities are performed and as an approximate height chosen in a study conducted by Bonutti *et al.* (2016) and Fatahi *et al.* (2017).

A manufacturer calibrated TM-196 3 Axis RF Field strength meter was used to measure the RF magnetic fields. The tenmars (TM) -196 can measure the RF fields ranging from 10 MHz to 8 GHz. Prior to measurement collection, the TM-196 3 Axis RF Field strength meter was mounted on the aluminium tripod at a height of 1 m from the ground, with the sensor facing the MRI scanner. The exposure levels for RF magnetic fields were measured at distance of 1 m from the MRI scanner gantry on right and left side. Based on the specific absorption rate (SAR) limit values for a duration of six minutes (International Electrotechnical Commission, 2010), exposure levels were measured on an average of six minutes and recorded on a data-recording sheet in microTesla (μT). A stopwatch timer was used to determine the recording time

once the MRI personnel start to actuate the RF pulse. The measurements were collected at a distance of 1 m only when MRI scans were performed on patients. In each side of the scanner, 30 measurements were collected when brain scans were performed, 30 during cervical spines and 30 during extremities scans. A total of 180 measurements from each scanner, which resulted to 540 measurements, collected for RF magnetic fields exposures from the three scanners in both hospitals.

*SMFs spot monitoring: measurements on the left and right side were collected adjacent to the magnet housing. Front measurements were collected next to the patient table. All measurements were taken in zone IV. **RF magnetic fields spot monitoring: measurements were collected adjacent to the magnet housing (gantry).

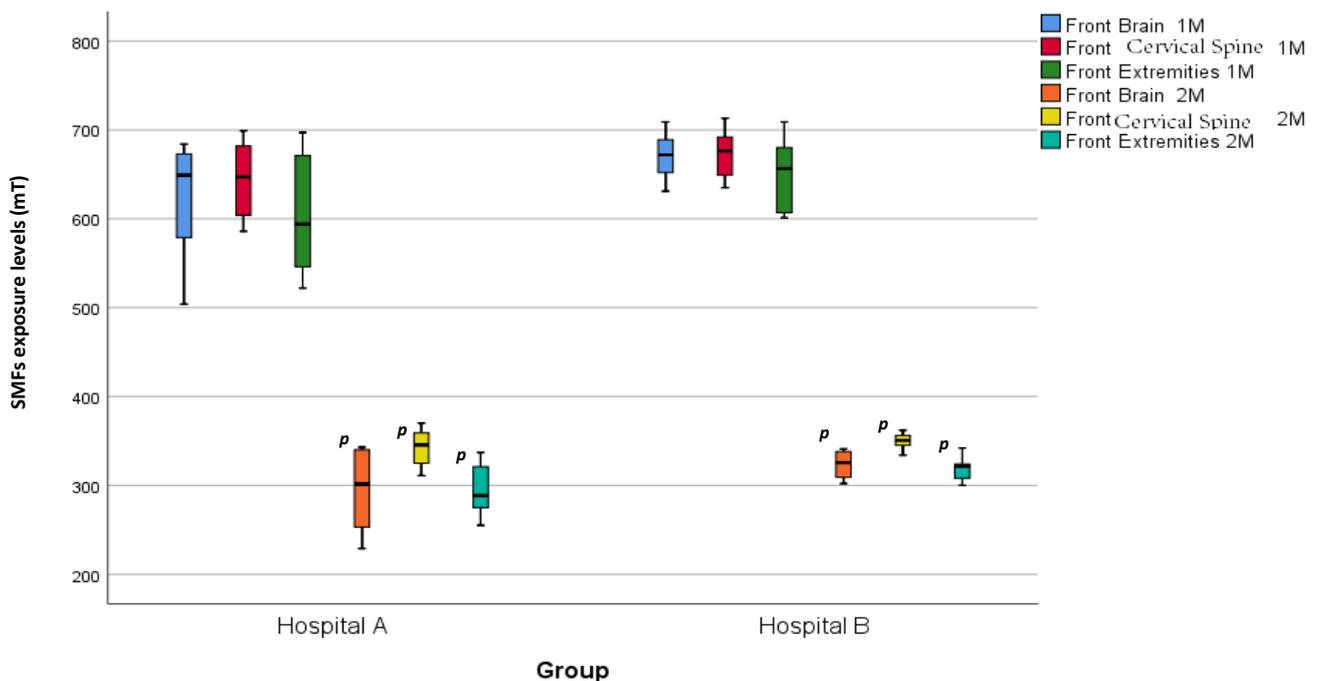
Figure 3.2a: Comparison of SMFs exposure levels measured on the front side at 1 and 2 m in hospital A and B

The stray SMFs emissions were compared between hospital A and B from two different 1.5 T MRI scanners. Parametric analysis were performed using the Shapiro-Wilk test to assess underlying differences between exposure levels recorded from the front of both scanners in 1 and 2 m. Exposure mean values recorded for different scan

procedures. i.e. brain, cervical spine and extremities were considered and no significant differences were observed. However, the independent sample test performed using Levene’s test for equality of variance suggested a statistical significant difference for extremities at 2 m ($p < 0.026$). Similar comparisons made for 1.5 T scanners in both hospitals for the right side suggested a statistical significant difference when exposure levels recorded for extremities at a distance of 2 m ($p < 0.012$) were performed (Figure 3.2b). In contrast, exposure levels recorded on the left side of both scanners in 1 and 2 m when brain, cervical spine and extremities were scanned shown a statistical non-significant difference (Figure 3.2c).

*Mean exposure values displayed in table 1; $p =$ significant difference

A non-parametric Friedman's test was used to compare exposure mean values in all measurement positions when different scans were performed in both hospitals. At 1 m, a statistical significant difference in hospital A ($p < 0.014$) for the left side and also hospital B for the right side ($p < 0.008$) was found. At 2 m, both hospitals showed a statistical significant difference for the front side ($p < 0.025$ and $p < 0.001$) and right side in hospital A ($p < 0.020$). Furthermore, the Wilcoxon test was performed for all measurement sides and Bonferroni adjustment was applied (0.02). At 1 m in hospital B, the difference was observed between cervical spine and extremities ($p < 0.005$) and in hospital A, there was a difference between cervical spine and the brain ($p < 0.013$). At 2 m in hospital A, differences in the front side were observed between cervical spine and brain mean values ($p < 0.017$) as well as extremities and cervical spine ($p < 0.013$) (Figure 3.2a). Similarly, differences were observed between the cervical spine and

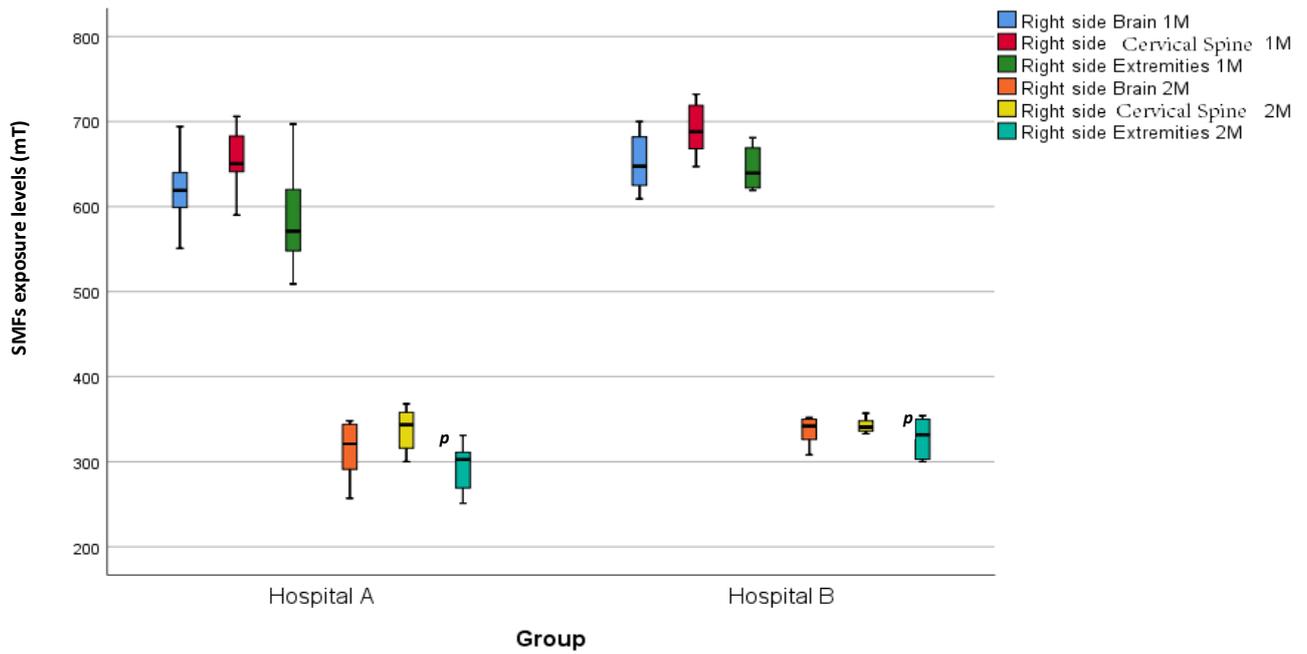
Figure 3. 2b: Comparison of SMFs exposure levels measured on the right side at 1 and 2 m in hospital A and B

*Mean exposure values displayed in table 1; p = significant difference

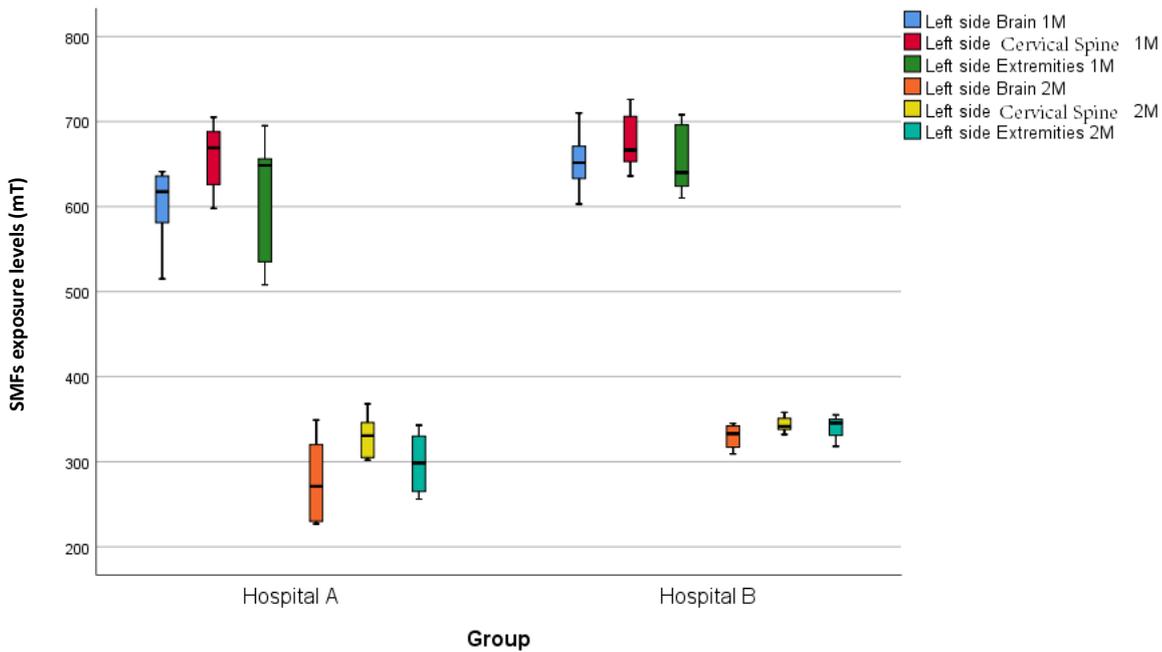
Figure 3.2c: Comparison of SMFs exposure levels measured on the left side at 1 and 2 m in hospital A and B

*Mean exposure values displayed in table 1

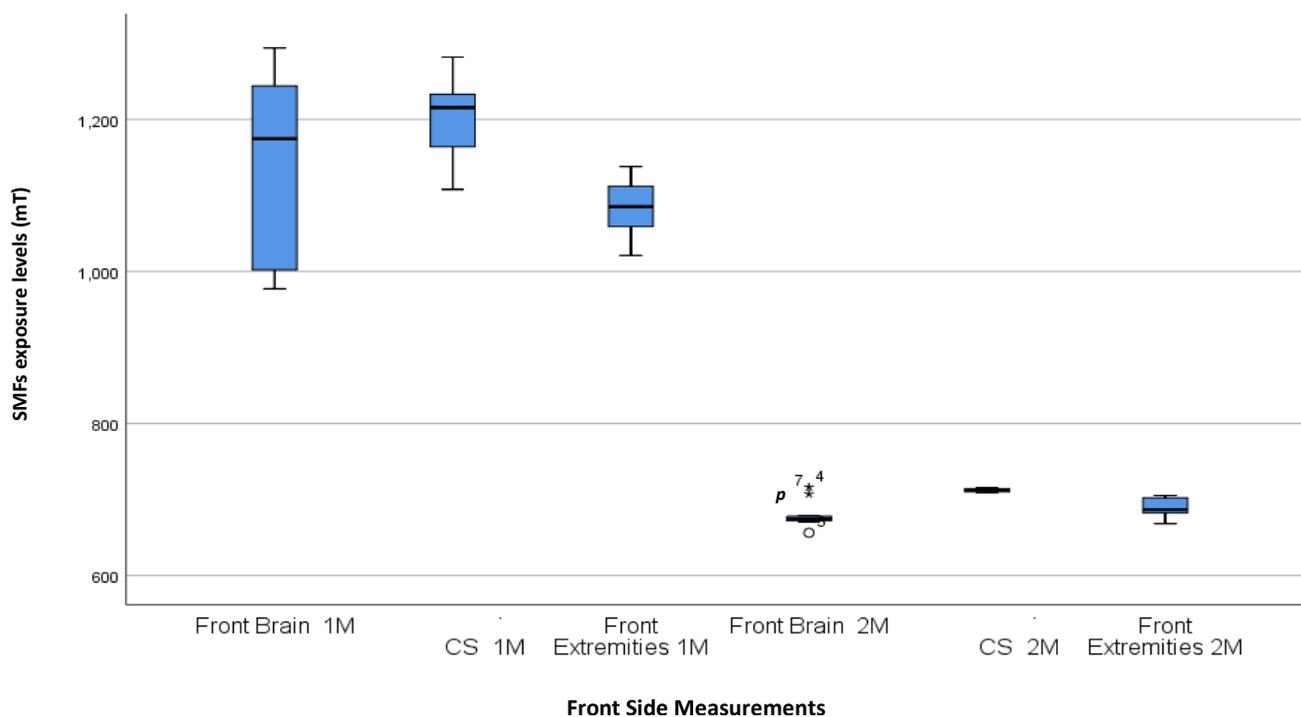
Figure 3.3a: SMFs exposure levels measured on the front of 3.0 T scanner at 1 and 2 m

*CS= cervical Spine; mean exposure values displayed in table 2; p= significant difference

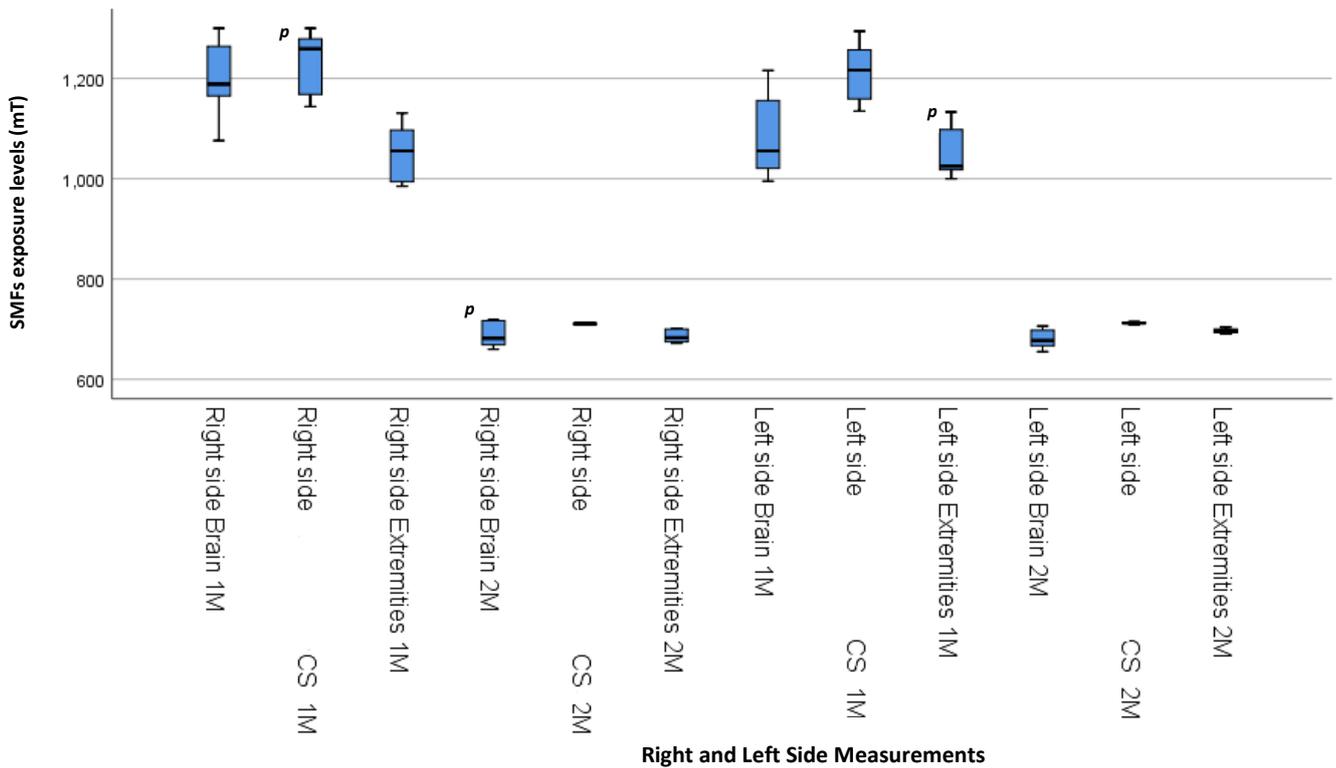
Figure 3.3b: SMFs exposure levels measured from the right and left side of 3.0 T scanner

*CS= Cervical Spine; mean exposure values displayed in table 1; *p*= significant difference

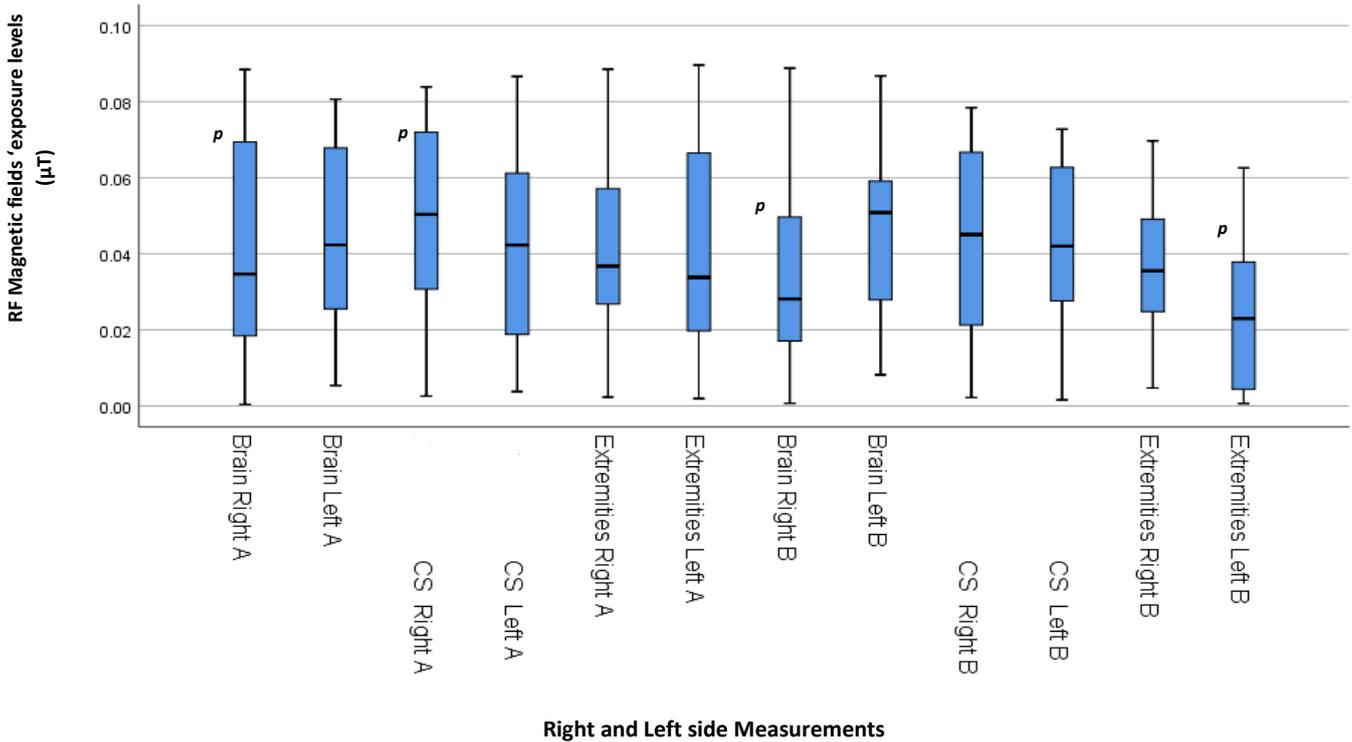
Figure 3.4a: Distribution of RF magnetic fields recorded at hospitals A and B from two 1.5 T MRI scanners

The RF magnetic fields emitted by two 1.5 T scanners were compared to evaluated compliance with ICNIRP of 2020, reference levels for local exposures averaged over 6 minutes (located in Table 3.3). The Incident H-field strength of 0.36 A m^{-1} occupational exposure limit was converted to $0.45 \text{ } \mu\text{T}$. Two 1.5 T scanners were compared to each other to assess if there is any difference with regard to RF magnetic fields emission on two sides of the scanners (right and left). Furthermore, RF emissions from 3.0 T scanner in hospital A were also measured to evaluate compliance. This was done by comparing exposure levels from different sides of the scanner when brain, cervical spine and extremities were scanned. Exposure levels were recorded for an average of 6 minutes at each measurement spot, when RF pulse was activated. The distribution of RF magnetic field levels is presented in Figure 3.4a and 3.4b below.

*CS= Cervical spine; A= Hospital A- mean 0.043 µT Std. 0.003; B= Hospital B- mean 0.039 µT Std. 0.008; p= significant difference

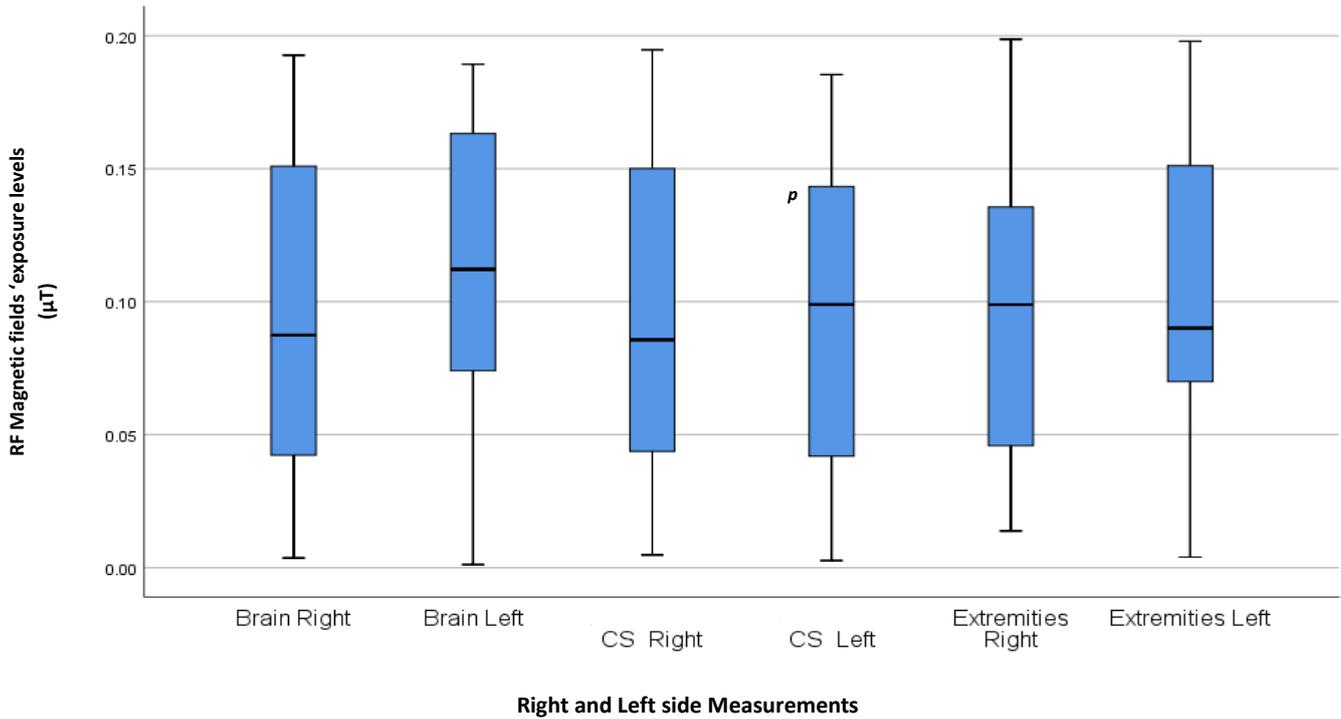
Figure 3.4b: Distribution of RF magnetic fields recorded from 3.0 T MRI scanner

The repeated measurements recorded during brain scans varied significantly for the right ($p < 0.02$) and left side ($p < 0.04$), and also for cervical spine ($p < 0.05$) on the left side of the scanner. Using a Wilcoxon's test to compare exposure levels recorded during brain, cervical spine and extremities' scans on the left and right side of the scanner, a non-significant difference was found. A paired samples correlation was performed to determine if exposure levels recorded on both sides of the scanner were correlated, and no correlation was found. Figure 3.4b below presents quantile distribution of RF fields during different scan procedures.

*CS= Cervical spine; Hospital A- Mean 0.1 µT Std. 0.006; p =significant difference

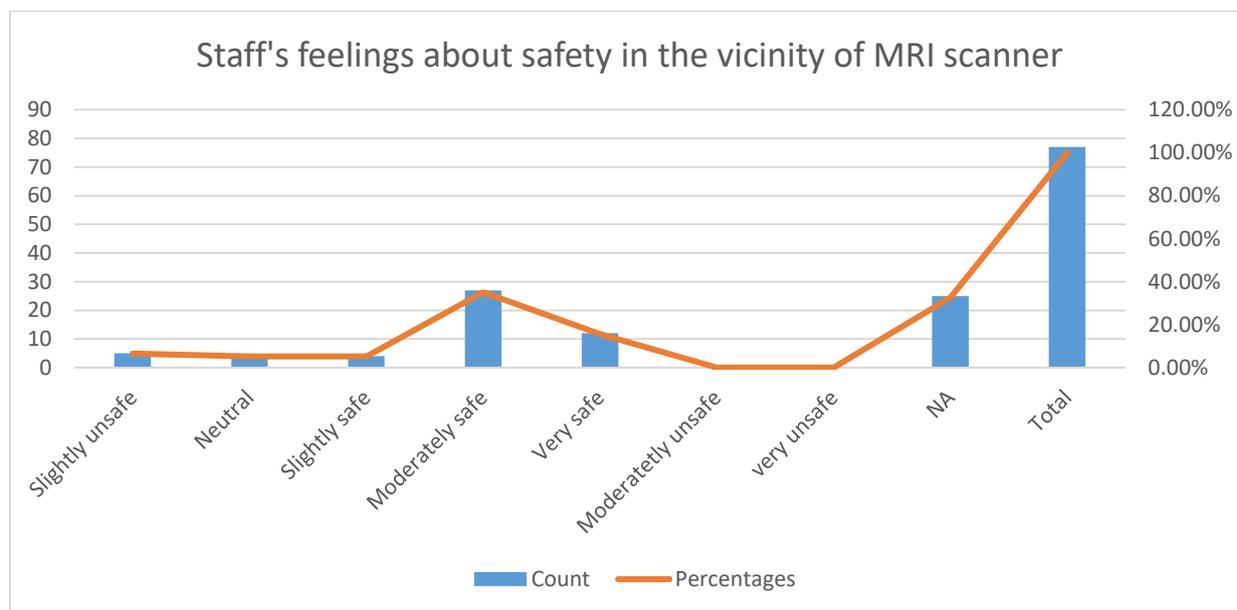
Figure 4.1: Perceptions of MRI scanner safety among MRI staff

The results for perceived MRI safety are presented in Figure 4.1. The responses of participants ranged from very safe to very unsafe. Out of 67.53% respondents, 15.58% felt very safe, while 35.06% felt moderately safe, and 5.19% felt slightly safe around MRI scanners. Only five (6.49%) participants felt slightly unsafe and 5.19% felt neutral, and none of the participants reported to have felt moderately and very unsafe.

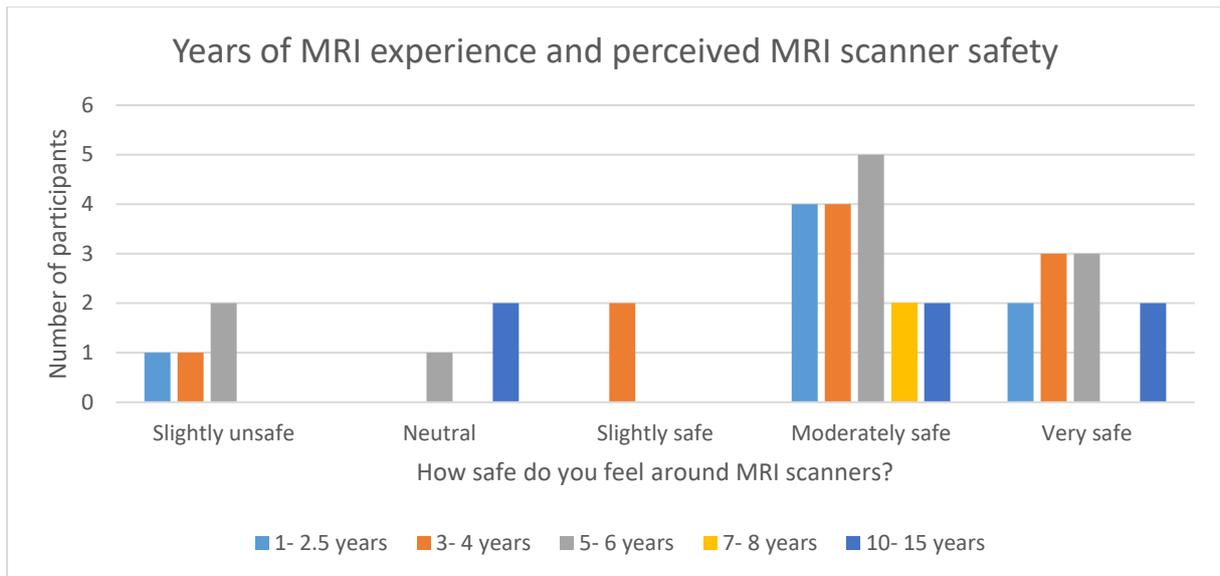
Figure 4.2: Years of experience in the MRI units and safeness around MRI scanners

No significant difference was found between participants working with scanners with different strengths (i.e. 1.5 T and 3.0 T, and both), and how safe they felt around the scanners ($p < 0.12$). However, when comparing the number of years working in the MRI units and safeness around the scanners, a significant difference was found ($p < 0.0002$). The majority of participants ($n=26$) felt safe (moderate and very safe) around MRI scanners, while only three felt slightly unsafe, and three were neutral. Participants who had between five and six years of experience working in the MRI units felt safer (moderately) around MRI scanners than other participants. The difference in years of experience in the MRI and feeling safe around scanners is depicted in Figure 4.2.

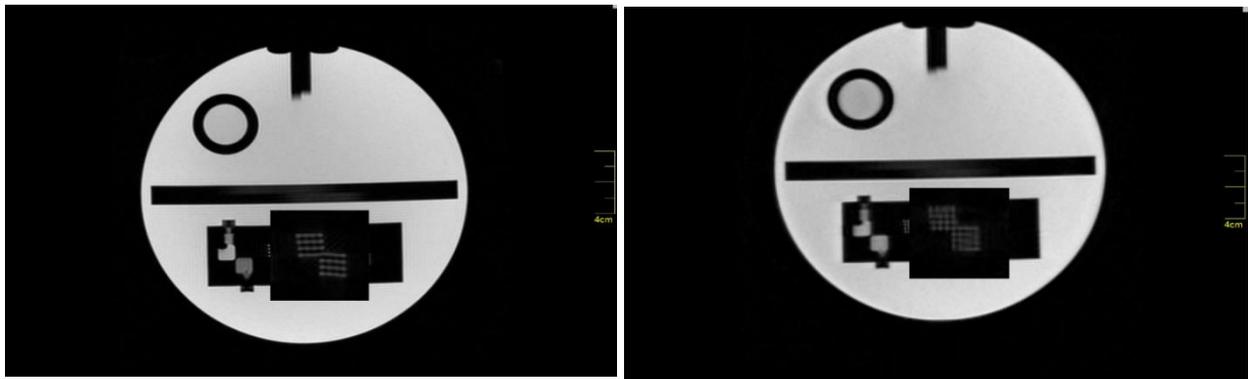
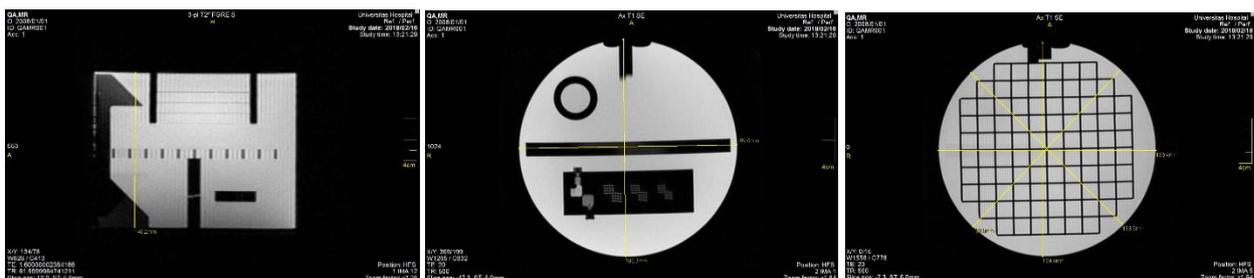
Figure 5.1: a) High spatial resolution b) Geometric accuracy

The geometric accuracy test was performed to assess whether geometric distortion could occur during the scanning process. The phantom dimensions in the image were similar to the true dimensions. As prescribed by the ACR procedure, the phantom dimensions were measured in the localizer, slice 1 and slice 5 of the axial series and the localizer presented an accuracy of 146.2 mm. The absolute value for the percentage of geometric distortion did not exceed 2% (Figure 5.1.b). The real inner diameter of the phantom was 190 mm and the inside end-to-end length was 148 mm, meeting standards of the ACR guidance (Ron *et al.*, 2015), which allows for a ± 2 mm deviation. With a resolution insert located in slice 1, a high contrast spatial resolution test was conducted to determine the scanner's ability to resolve small high-contrast objects within close proximity of each other. Furthermore, the field of view and matrix size for the axial series were chosen to produce a resolution of 1.0 mm in both directions (Figure 5.1.a). The measured resolution of both axial series was 1.0 mm in both directions.

5.1 a) High spatial resolution

5.1 b) Geometric accuracy

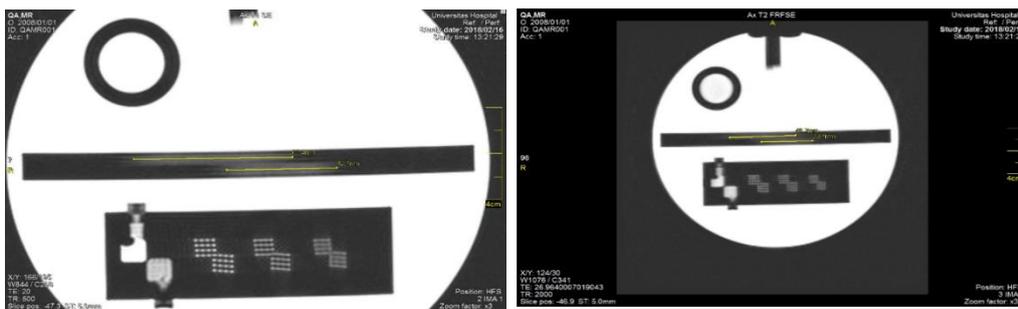
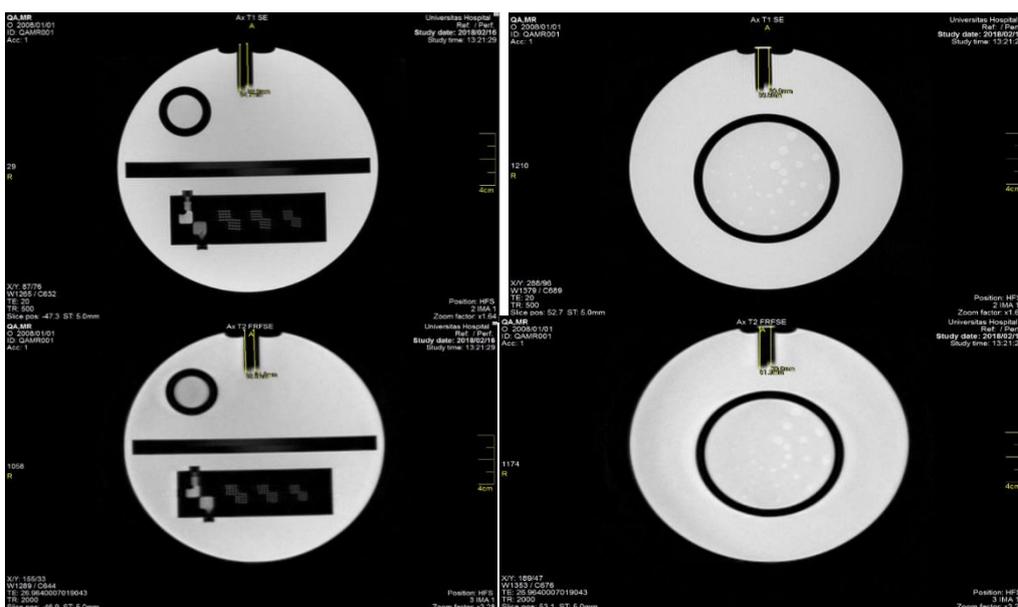
Figure 5.2: a) Slide thickness; and b) Slice positioning accuracy

On both ACR series the measured slice thickness was 5.6 mm and 5.3 mm, resulting in the scanner passing the slice thickness test ($5.0 \text{ mm} \pm 0.7 \text{ mm}$) (Figure 5.2.a). The radiofrequency (RF) amplifier nonlinearity did not cause any distorted RF pulse shapes and no thickness error was identified on either ACR series. The absolute bar length difference for slice 1 and slice11 (Figure 5.2.b) for position accuracy was less than 5 mm.

5.2 a) Slide thickness

5.2 b) Slice positioning accuracy

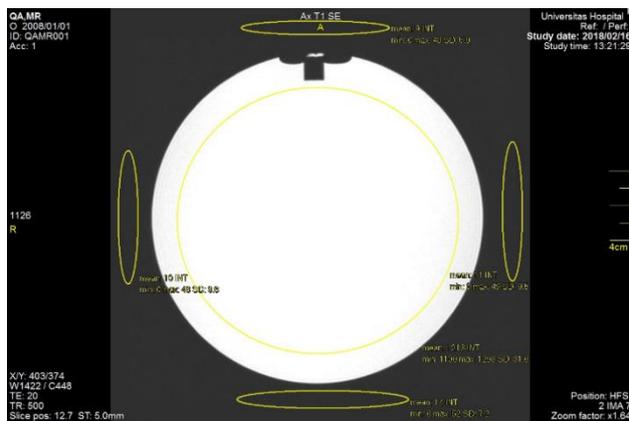
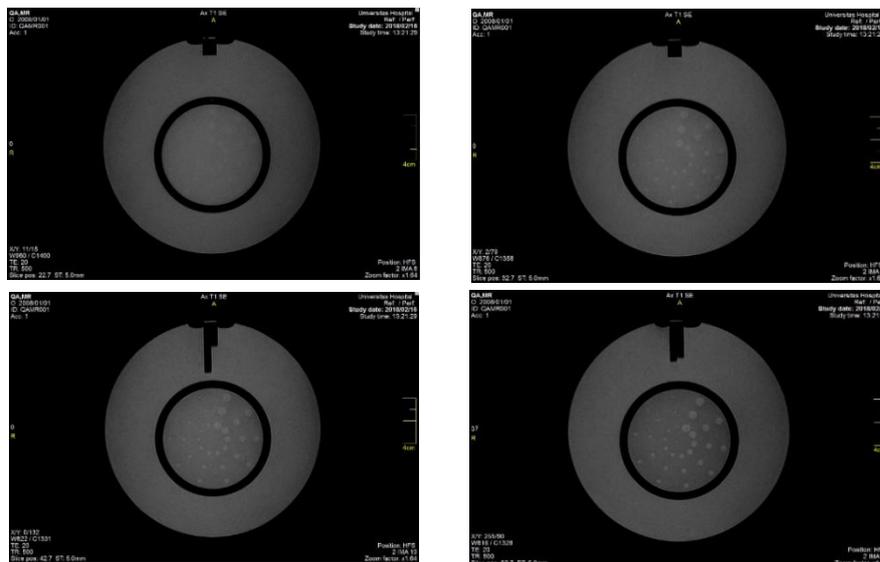
Figure 5.3: a) Image uniformity intensity, and b) Low contrast object detectability

In order to determine ghost ratio, five intensity measurements were made for the ACR T1 series; the average intensity in the image of the phantom, as well as the average intensity in the background at four locations outside of the phantom. The ghosting ratio was 0.00678, being less than the acceptable ghost ratio value of less than or equal to 0.025 (2.5%).

5.3 a) Percentage signal ghosting

5.3 b) Low object detectability

Measurements were made for ACR T1 and T2 series using four slices for low contrast detectability. In each slice, the low contrast objects appeared as rows of small disks, from the centre of a circle. All the disks on each slice had the same level of contrast. In order, the contrast values were 1.4%, 2.5%, 3.6%, and 5.1% (Figure 5.3.b). All the disks in a given spoke had the same diameter. The measurements comprised counting the number of complete spokes seen in Figure 3.b. The ACR T1 had a total score of 40 spokes, while T2 failed with a total of 29 spokes (ideal ≥ 37).

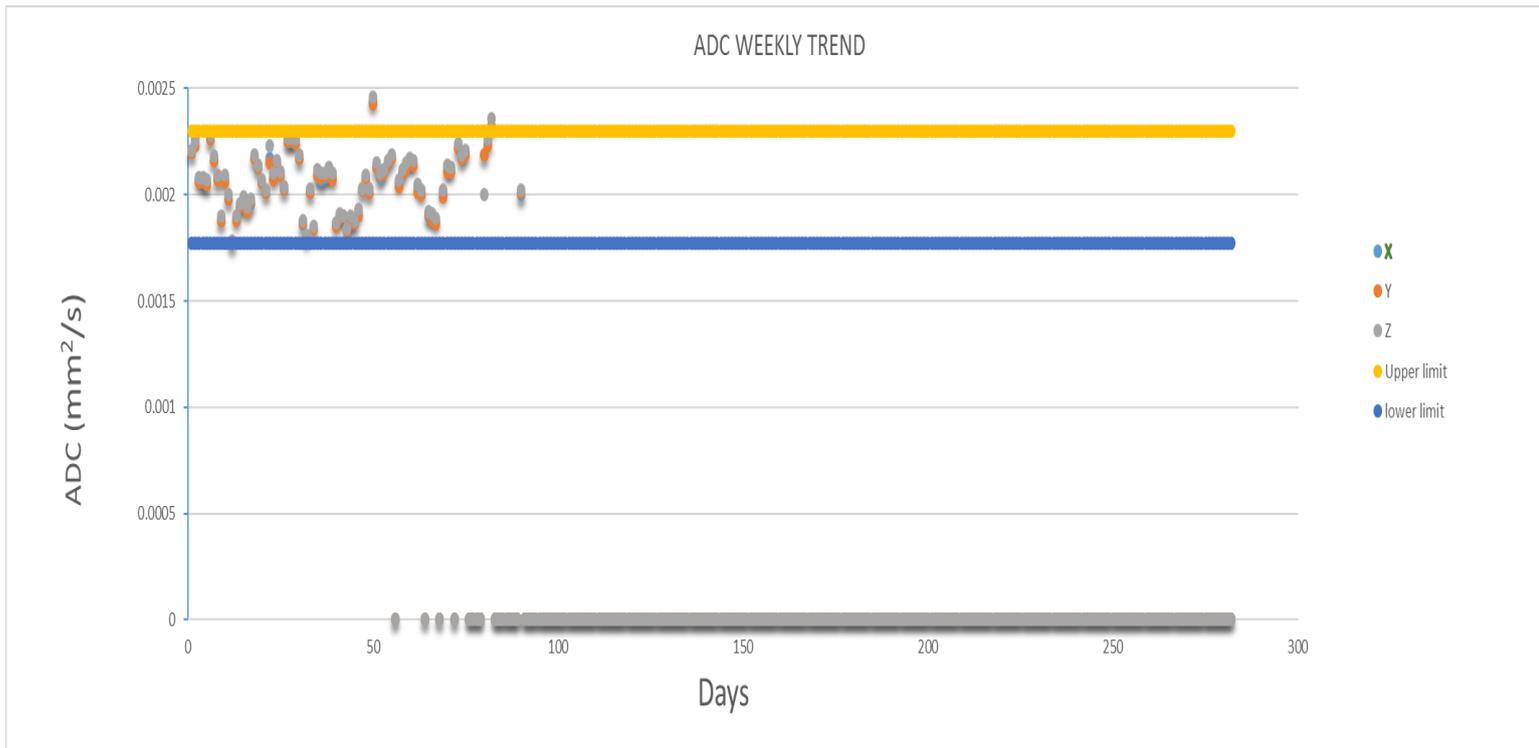
Figure 5.4: Apparent diffusion coefficient weekly trend for 2018

The ADC values were well within the acceptable range; however, it was noted that some measurements were influenced by varying temperatures on certain days (Figure 5.4). None of the measurements were below the low acceptable limit.

* X (R/L); Y (A/P); Z (S/I)

*Upper limit: 0.002301; Lower limit: 0.001773

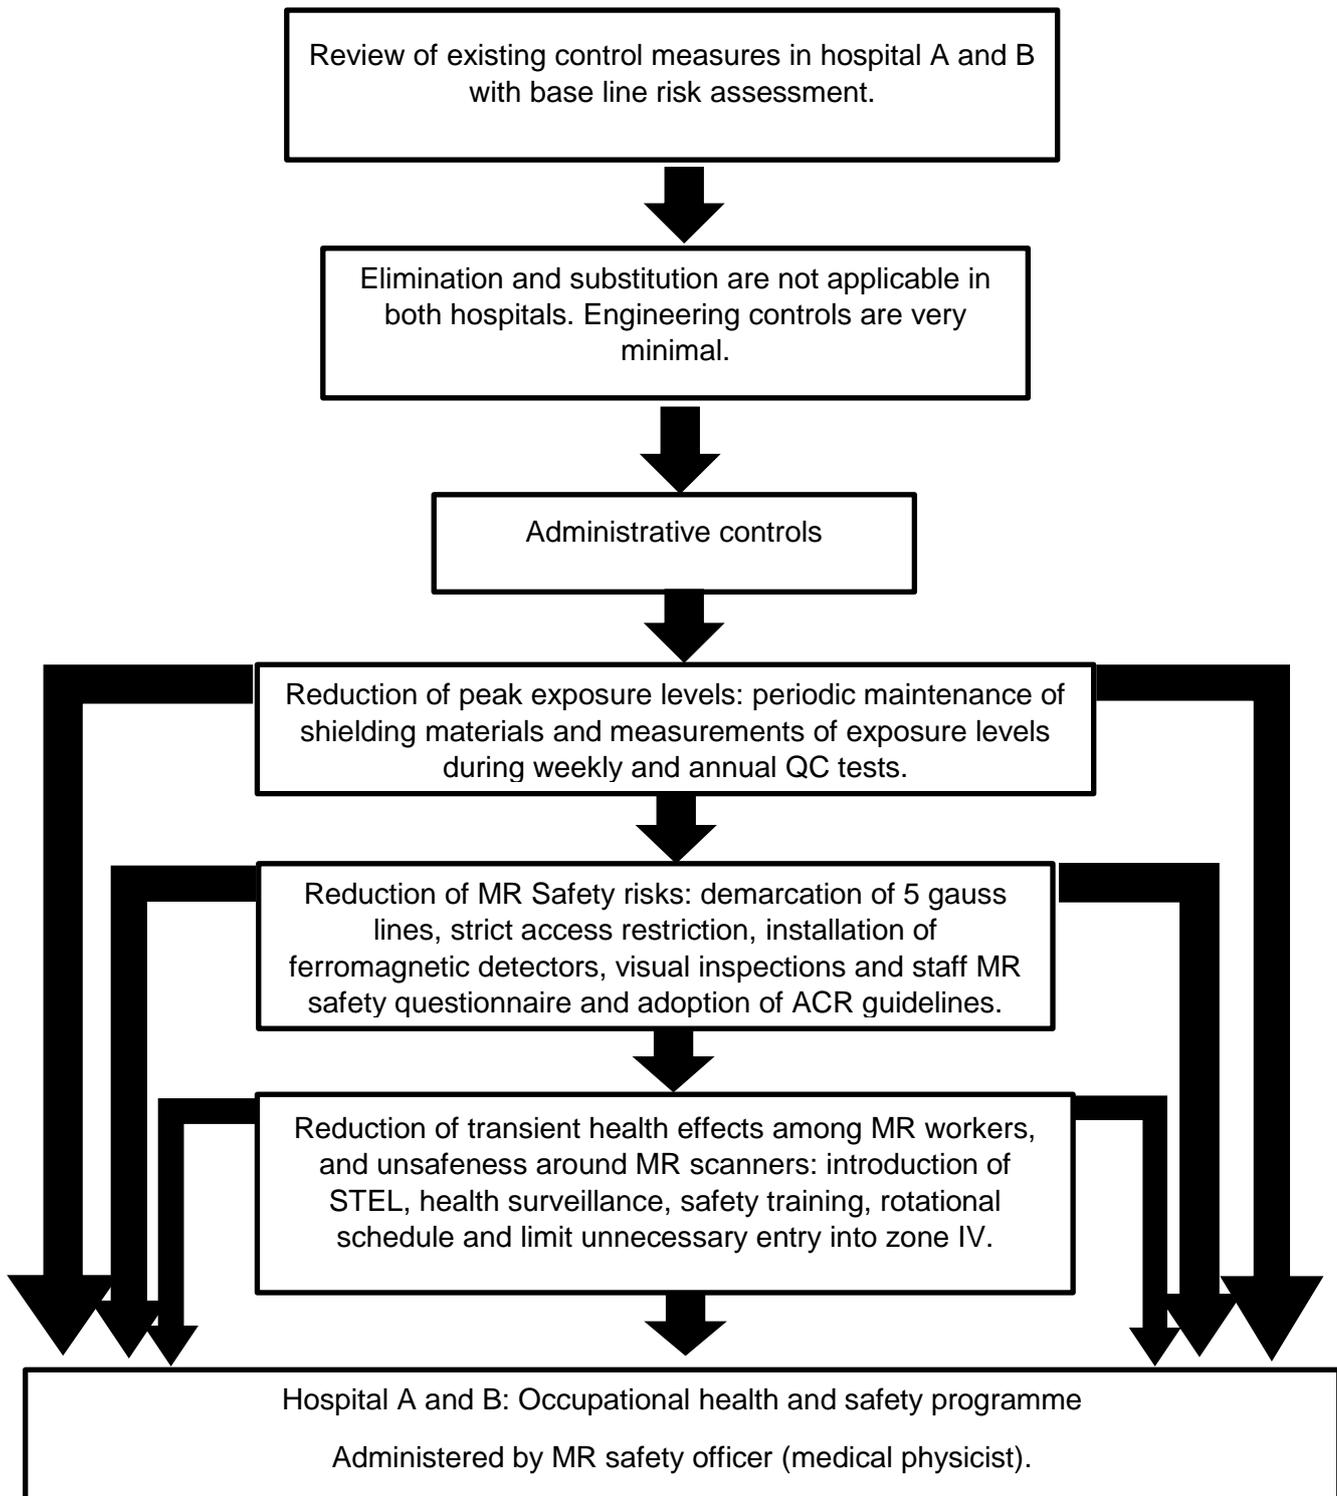
Figure 6.1 flow diagram of control measures for hospitals A and B

This model is based on the hierarchy of controls for occupational hygiene, which include elimination, substitution, engineering, administration controls and the use of personal protective equipment (PPE) to mitigate occupational risks and hazards. However, due to the effectiveness of existing control mechanisms in hospital A and B, this model is based on administrative controls with few recommendations made on the use of PPE. Figure 6.1 below illustrate control measures applicable in hospital A and B.
