A CASE STUDY OF RAPID SAND CASTING DEFECTS

ABSTRACT

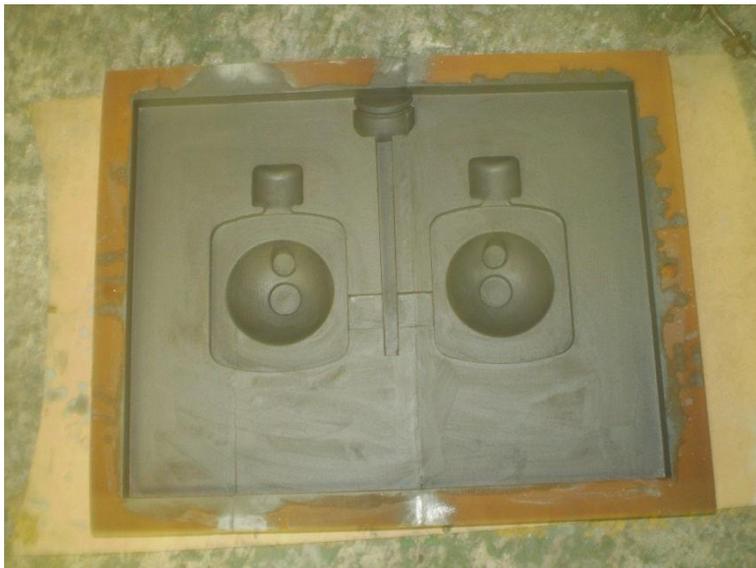
Figure 4: Drag component of the mould with the internal cavity of the tool to be cast.

The entire mould was made of four sand parts that were grown on an EOSINT S700 laser sintering machine at the Centre for Rapid Prototyping Manufacturing (CRPM) at the Central University of Technology in Bloemfontein [9]. The various sand parts were glued together to form the cope and the drag. The internal cavity of the mould was spray coated with graphite paint to improve the surface finish of the final casting (Figure 4). Before pouring the molten metal, the mould was placed in a frame filled with backing sand and weights were placed on top as shown in Figure 5 in order to make it able to withstand the metallostatic pressure of the liquid metal. Gravity casting using a ladle operated manually was employed to cast the mould.

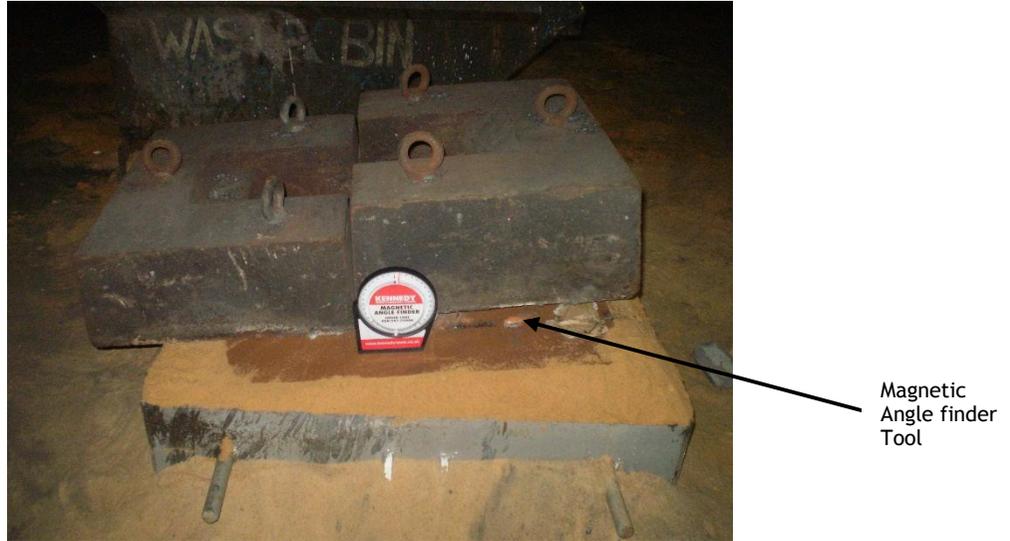
Figure 5: Assembled mould with weights and required inclination (see magnetic angle finder tool) ready to be poured.

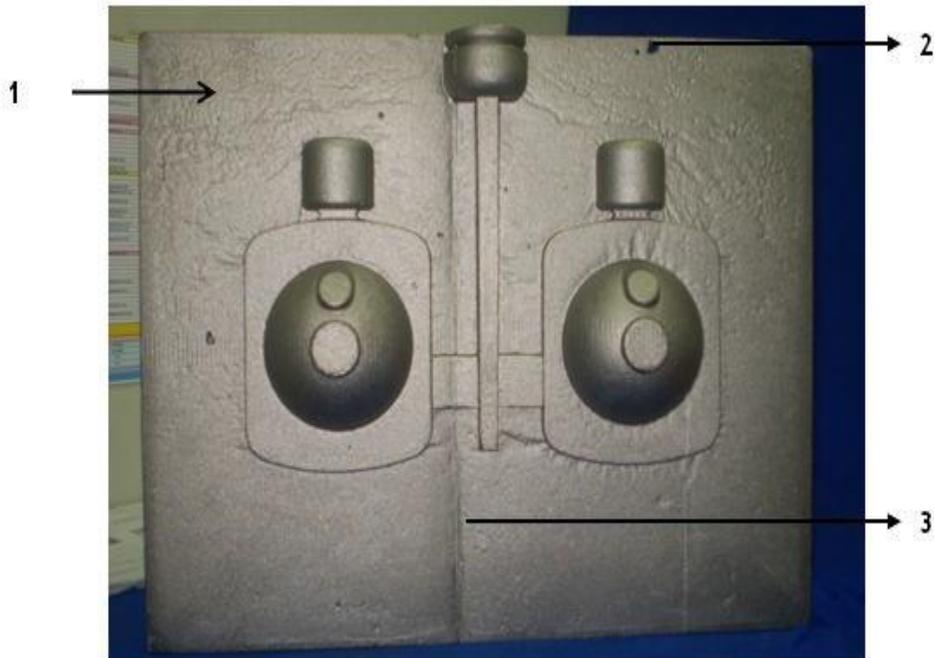
Figure 6 shows the front picture of final sand casting plate. The finishing operations included sand blasting and fettling to remove the casting runners. No machining of the cast pattern was performed.

The final casting picture revealed evidence of noticeable defects including:

1. Cold lap mainly visible in the top half of the casting
2. Gas porosity in top right region
3. Vertical alignment fault in the middle of the casting

Cold lap defects are generally due to poor metal fluidity. Low pouring temperature is usually the main culprit for low metal fluidity. Mould factors related to thermal properties, surface effects and air pressure could also cause inadequate effective fluidity of the cast alloy [7] resulting in cold lap defects. Gas porosity defects are mainly due to sub-optimal mould permeability to allow gas escape during casting [8]. Finally, misalignment is generally due to inadequate jointing of the mould components to produce the final casting cavity. Figure 6 also revealed a general loss of dimensional accuracy.

It is the opinion of authors that the casting defects experienced in this case study could be chiefly attributed to the workmanship of manipulating laser sintered sand moulds. The jointing of the moulds components were not done correctly. Backing sand was used to increase the strength of the mould but had inadequate green strength and permeability. As a result of this incorrect application of the sand technique, a mould leak occurred during the casting trial. Thus the top section of the casting was subsequently filled with cold metal resulting in the occurrence of cold lap defect. The feeding system reservoirs could not be adequately filled with molten metal thus the apparition of shrinkage and porosity defects. Finally the poor joining of the sand mould components was solely responsible for the vertical alignment fault.

Figure 6: Final casting exhibiting some defects: 1: cold lap; 2: porosity; 3: Alignment fault

The casting defects suffered in this casting trial were unlikely to occur had traditional moulding methods be used with minimal requirements for joining mould components and elimination of backing sand use. Foundrymen are well familiar with these traditional moulding methods. Fortunately, the casting defects were not deemed to be deleterious enough to be scrapped the final casting. This casting could be salvaged by machining to produce a useful sand pattern.
